ADMINISTRATION BUILDING

Livingston School District
Administration Building

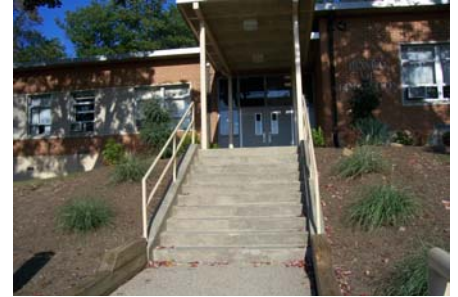
EX-01 Site:

Asphalt parking areas are cracked, sinking and breaking up. Existing striping and directional arrows are fading and hard to see. Front and side entrance concrete steps lack non-slip nosings and handrail extensions. Fencing surrounding exterior mechanical equipment is in disrepair.

Mill and resurface the cracked, sinking and breaking up drives and parking areas. Paint stripe parking bays, directional arrows and fire zone markings. Provide ADA complying handrails at the exterior stairs for barrier free access to main entrance. Replace mechanical equipment fencing.

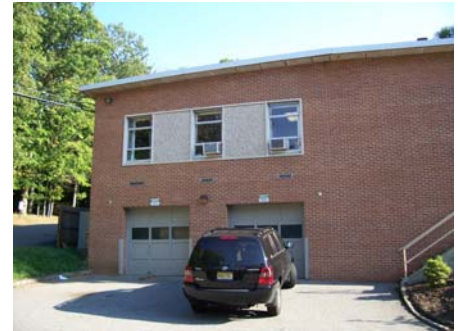
EX-02 Masonry Walls:

The exterior of the building is a partial two-story, full height, brick-faced masonry wall. The brick masonry appears in good condition with no major cracking noticed. Caulking at doors, windows and louvers is dried out and cracking.

Doors, windows and louvers should be re-caulked.

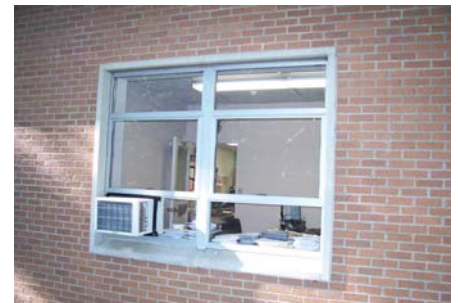
EX-03 Windows:

Exterior walls have original aluminum windows, which are single glazed, non-thermal break and energy inefficient. There are a few windows at the Addition that are new and do not need to be replaced.

Replace the original windows with new thermal break windows with 1" thick insulating glass. Paint lintels with rust inhibitive paint.

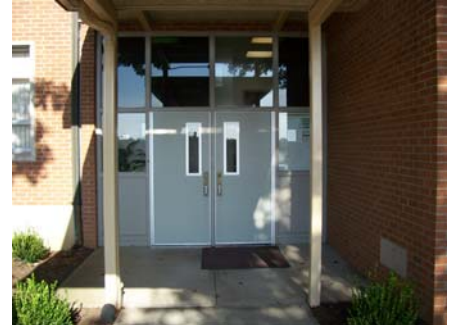
EX-04 Doors:

The front entrance door is FRP, without lever handles on the exterior side. The remaining exterior doors are aluminum. Existing metal frames appear in acceptable condition.

Replace FRP doors not meeting ADA required width. Replace all hardware on exterior doors with lever handles. Clean existing metal frames and paint same. Replace all caulking at existing frames.

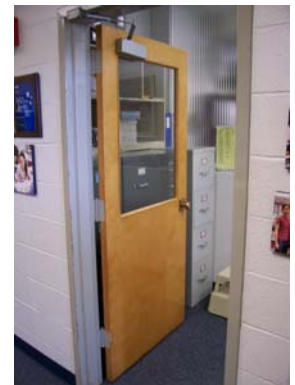
IN-01 Wood Doors:

Certain corridor doors do not comply with code fire-rating requirements (1/3 hr.). Door hardware does not comply with ADA requirements. The double doors to the meeting room are 2' - 6" in width, which do not meet the ADA required width.

Replace non-complying fire-rated doors with 1/3 hr. rated complying doors and hardware. Replace non-complying door hardware with ADA complying hardware.

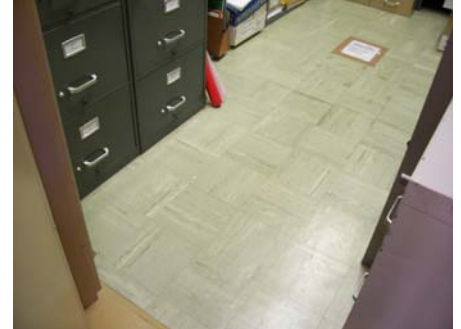
IN-02 Floor Tiles:

The floor at the vault has 9" x 9" vinyl tiles, which may be indicative of containing asbestos.

Even though the tiles are non-friable, it is suggested that the Board have the tiles tested to ascertain if they contain asbestos. The Board may wish to have its abatement consultant prepare a schedule to remove any tile found to contain asbestos. This office will then provide the documents to replace the tile accordingly.

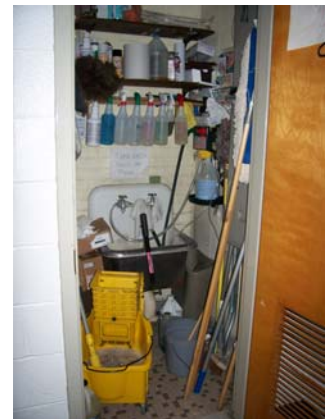
IN-03 Janitor Closets:

Janitor closet was found to be in poor condition due to its age.

Prep and paint all walls, floors and ceilings. Install new slop sinks/mop sinks and stainless steel equipment hanger strips and shelving.

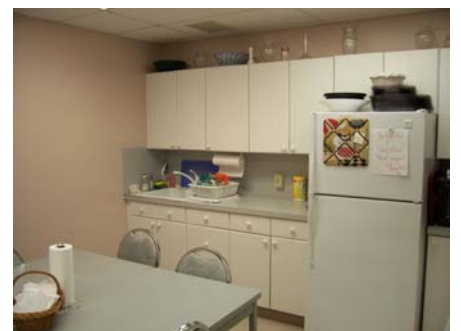
IN-04 Break Room Sink Cabinets and Counters:

The sink cabinets and counters in the break room do not meet ADA requirements for height, sink lever handles and trim, ADA approach requirements.

Replace break room sinks, sink cabinets and counters to meet ADA and code requirements.

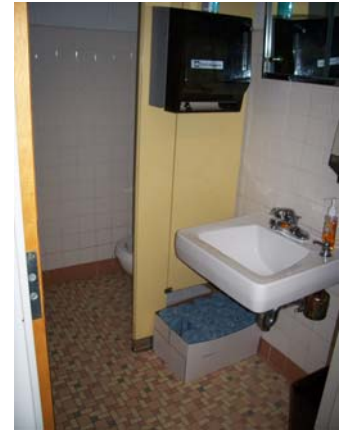
IN-05 Toilets:

The men's toilet in the building does not meet ADA requirements. The women's toilet does meet ADA requirements. There is a uni-sex single toilet that does not meet ADA requirements.

Renovate non-complying toilets with new fixtures, stalls, floor/wall/ceilings, accessories, etc. Replace doors, frames and hardware. Update ventilation systems and lighting.

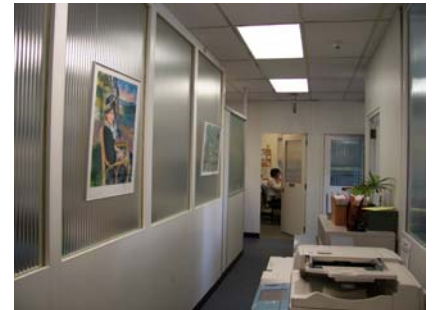
IN-06 Office Areas:

The existing ceiling tiles in most areas are in poor condition due to age. Carpet has normal wear and tear for its age and has been replaced in certain areas.

Replace suspended ceiling tiles and carpet as needed.
