COLLINS ELEMENTARY SCHOOL

Livingston School District
Collins Elementary School

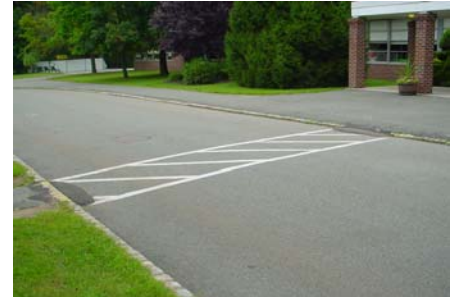
EX-01 Site:

Asphalt drives and parking areas are cracked and breaking up in some areas. Existing striping and directional arrows are fading and hard to see. Concrete sidewalks and curbing are deteriorating and in need of replacement in some locations.

Mill and resurface cracked and breaking up drives and parking areas. Paint stripe parking bays, directional arrows and fire zone markings. Cut out broken, sunken and deteriorated sections of concrete walkways and concrete curbing.

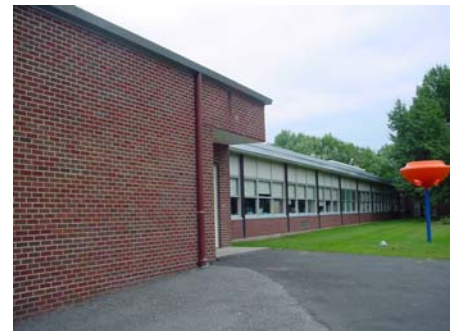
EX-02 Masonry Walls:

The exterior of the building is a one-story, full height brick-faced masonry wall. The brick masonry appears in good condition with no major cracking noticed. Caulking at original doors, windows and louvers is dried out and cracking. Some areas of fascia and trim need to be painted. The masonry walls at the 2002 additions are in good condition.

Even though no water infiltration was observed inside the building, spot masonry joint cut and pointing should be performed. Also, doors, windows and louvers should be re-caulked. No work at the 2002 additions is necessary.

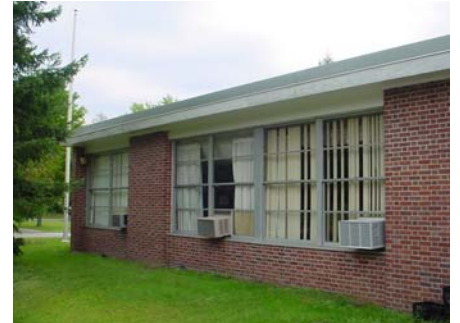
EX-03 Windows:

Exterior walls have original full height aluminum windows, which are single glazed, non-thermal break and energy inefficient. The 2002 Addition windows are new, thermal efficient and in good condition.

Replace the original windows with new thermal break windows with 1" thick insulating glass at North Wing, South Wing, South Courtyard, East Wing and Multi Purpose Room.

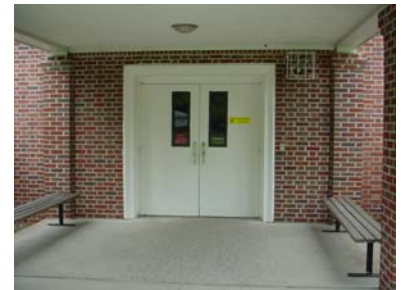
EX-04 Doors:

Exterior doors are aluminum or hollow metal, without lever handles on the exterior side. Exterior doors at the 2002 additions are FRP with compliant hardware. Existing metal frames appear in acceptable condition.

Replace existing doors with FRP doors. Replace all hardware on exterior doors with lever handles. Clean existing metal frames and paint same. Replace all caulking at existing frames.

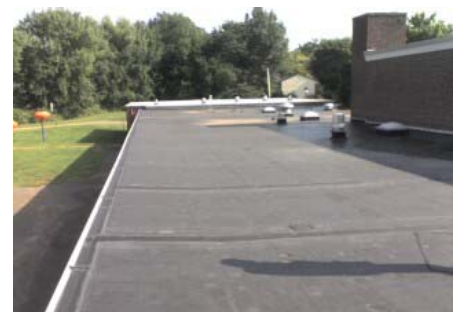
EX-05 Roofing:

The built up roofs have been replaced within the last 8 (two separate sections 1999/2001) years and are in good condition, no repairs are required. The EPDM roofs are nearing their historical life-cycle for this particular roofing system.

An infrared analysis shall be recommended for all EPDM roof areas to reveal possible wet and/or damp deficient roof insulation below. Seam reinforcement is suggested based upon Infrared results.

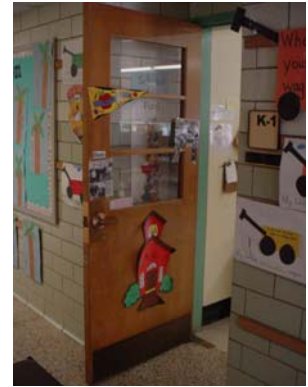
IN-01 Wood Doors:

Existing corridor doors do not comply with code fire-rating requirements (1/3 hr.). Interior door hardware has been retrofitted to meet ADA requirements, however a handful of doors were not upgraded. Many corridor doors do not meet ADA pull side dimension requirements. Louvers above doors do not have fire dampers. The doors at the 2002 additions meet requirements.

Replace non-complying fire-rated doors with 1/3 hr. rated complying doors and frames. Replace non-complying doors and door hardware with ADA complying widths and hardware. Provide louvers with fire dampers.

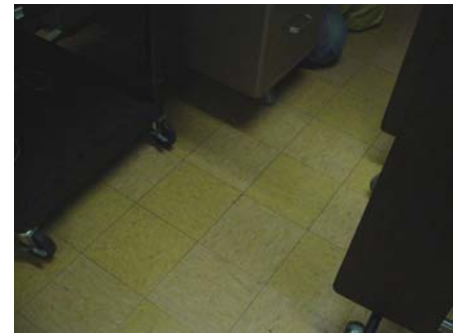
IN-02 Floor Tiles:

Certain rooms have 9" x 9" vinyl tiles in classrooms, which may be indicative of containing asbestos. The floor tiles at the 2002 additions appear to not contain asbestos.

Even though the tiles are non-friable, it is suggested that the Board have the tiles tested to ascertain if they contain asbestos. The Board may wish to have its abatement consultant prepare a schedule to remove any tile found to contain asbestos. This office will then provide the documents to replace the tile accordingly.

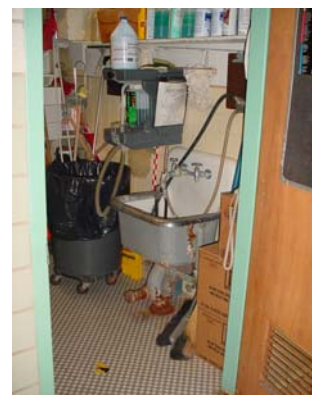
IN-03 Janitor Closets:

Janitor closets were found to be in poor conditions due to years of continuous hard use. The closets at the 2002 additions (where provided) appear clean and new.

Prep and paint all walls, floors and ceilings. Install new slop sinks/mop sinks and stainless steel equipment hanger strips and shelving.

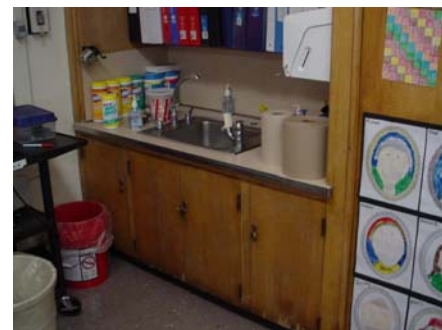
IN-04 Classroom Sink Cabinets and Counters:

The sink cabinets and counters in the classrooms were observed to be in poor condition from years of use. They also do not meet ADA requirements for height, sink lever handles and trim, insulated exposed piping, ADA approach requirements and D.O.E. bubbler/drinking fountain requirements (at Pre-K and Kindergartens). The classroom sink cabinets and counters at the 2002 additions meet requirements.

Replace all classroom sinks, sink cabinets and counters to meet ADA and code requirements.

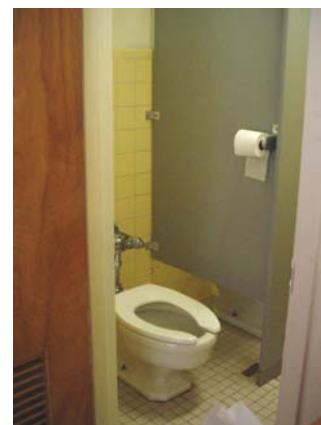
IN-05 Toilets:

Two sets of boys and girls' toilets appear to have been renovated and an attempt to meet ADA guidelines is apparent, however there are items missing (i.e., grab bars and pipe insulation), which do not make them compliant. There is a set of men and women's faculty toilets, which do not meet ADA requirements. None of the toilets within the classrooms meet ADA requirements. New toilets in the 2002 Addition meet all requirements.

Renovate toilets with new fixtures, stalls, floor/wall/ceilings, accessories, etc., and reconfigure to meet ADA. Replace doors, frames and hardware. Install insulation on sink piping. Update ventilation systems and lighting.

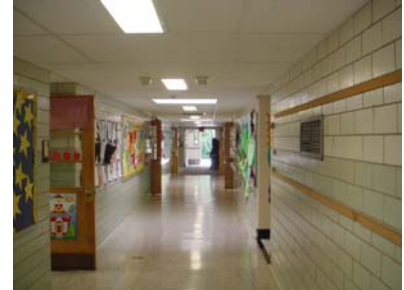
IN-06 Corridor Ceiling:

Existing corridor height is 7' - 7 ½", which does not meet the minimum height allowed of 8' - 0".

Provide new ceiling at correct height, if possible, based upon further determination of duct and piping conditions above the ceiling. Re-install existing lighting, smoke detectors, etc.

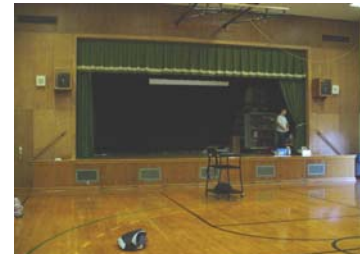
IN-07 Stage ADA Access:

No wheelchair access to the stage was observed.

Provide an ADA complying wheelchair lift to the stage floor from the Multi-Purpose Room floor.

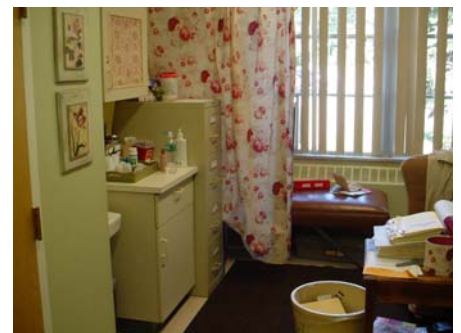
IN-08 Nurse's Office:

The Nurse's Office does not meet ADA requirements for doors, hardware and toilet room.

Provide new uni-sex toilet room meeting all ADA requirements, new doors 3' - 0" in width and lever door hardware. Provide new finished flooring and paint.

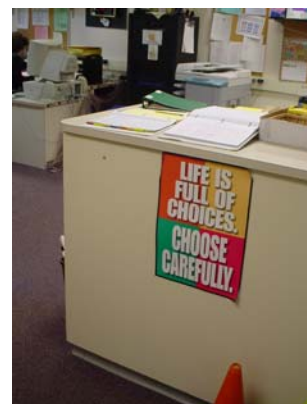
IN-09 Administration Area Reception Desk:

The Administration Desk does not provide for ADA wheelchair counter height.

Modify the Reception Area Desk to accommodate a 34" high counter area for the wheelchair disabled.
