BURNET HILL ELEMENTARY SCHOOL

Livingston School District
Burnet Hill Elementary School

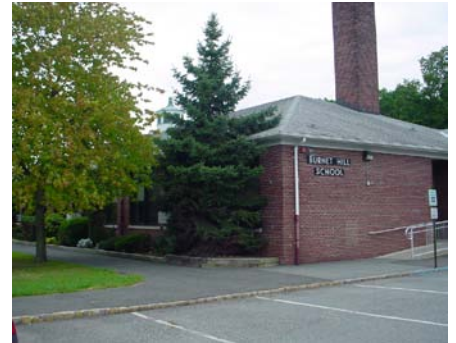
Burnet Hill Elementary School is located at 25 Byron Place and consists of a one-story building which has had a number of additions added to it over the years, the latest of which was a one-story media center and classroom addition completed in 2002. The existing building has masonry walls, tectum roof decks and concrete slab on grade. The new additions (2002) have masonry walls, metal deck at the roofs and concrete slabs on grade. The 2002 additions appear to meet all code requirements.

In general, the site elements are in fair condition with some sidewalks and curbing in need of repair. The ADA curb cut at the side of the building needs replacement. Asphalt milling and paving is needed at parking areas and driveways, with new striping, directional arrows and fire zone markings.

The exterior brickwork is in good condition and there were no signs of water infiltration through the exterior walls. Only a small portion of the windows are aluminum, single glazed, original and in poor condition. Most of the windows appear to be replaced within the last ten years and look to be in good condition. There is a separate roof condition analysis for this building elsewhere in the report. There was no sign of water infiltration through the roofs. The exterior doors are mostly FRP doors in hollow metal frames.

The interior of the building consists of masonry walls, 12" x 12" vinyl floor tiles, carpet and 9" x 9" asphaltic floor tiles, (which may be indicative of containing asbestos in a number of rooms) and wood corridor doors. The built-in casework in the original building are in poor condition due to their age. There are many handicapped measures not complied with, i.e. door hardware, classroom sink counters, toilets, and handrails.

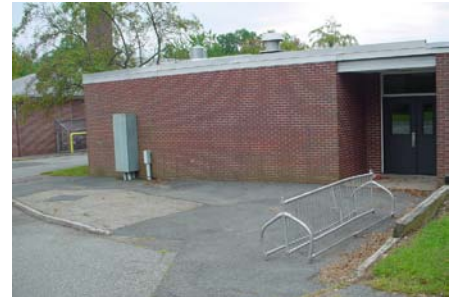
EX-01 Site:

Asphalt parking areas are cracked and breaking up. Existing striping and directional arrows are fading and hard to see. Concrete sidewalks and curbing are deteriorating and in need of replacement in some locations.

Mill and resurface the drives and parking areas. Paint stripe parking bays, directional arrows and fire zone markings. Cut out broken, sunken and deteriorated sections of concrete walkways and concrete curbing.

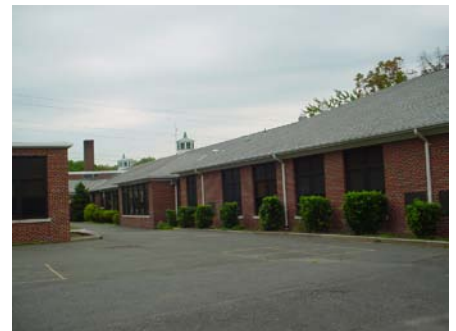
EX-02 Masonry Walls:

The exterior of the older building is a one-story full height brick-faced masonry wall. The brick masonry appears in good condition with no major cracking noticed. Caulking at original doors, windows and louvers is dried out and cracking. Some areas of fascia and trim need to be painted. The masonry walls at the 2002 additions are in good condition.

Even though no water infiltration was observed inside the building, spot masonry joint cut and pointing should be performed. Also, doors, windows and louvers should be re-caulked. No work at the 2002 additions is necessary.

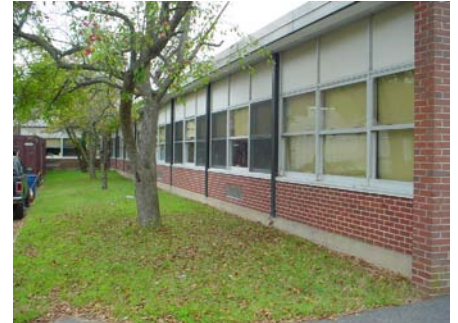
EX-03 Windows:

A good portion of the windows have been replaced with new thermal windows and screens. A few screens are torn, discolored and damaged. One wing on the rear of the school has original full height aluminum windows, which are single glazed, non-thermal break and energy inefficient. The 2002 Addition windows are new, thermal efficient and in good condition.

Replace the original windows with new thermal break windows with 1" thick insulating glass at northeast wing.

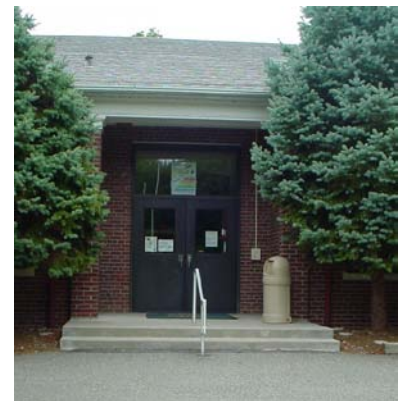
EX-04 Doors:

Exterior doors are FRP with compliant hardware. Existing metal frames appear in acceptable condition.

No action to be taken.

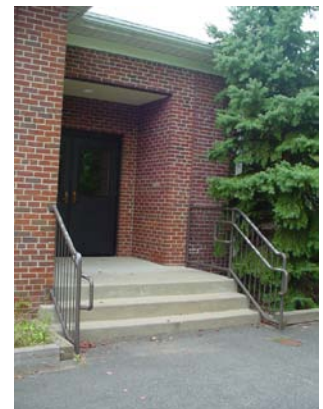
EX-05 Stairs:

Exterior stairs lack non-slip nosings. Handrails meet ADA requirements.

Replace stair nosings.

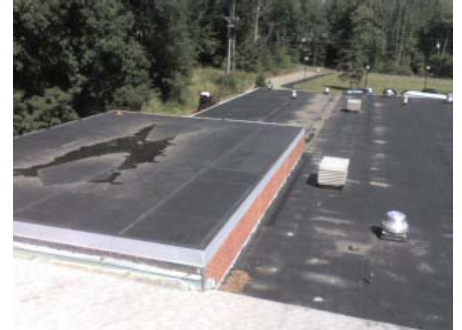
EX-06 Roofing:

A large portion of EPDM and built-up roofs are in poor condition, with seams failing and blistering and cupping of internal insulation boards. The majority of the shingle roofs are in good condition.

Replace the EPDM and built-up roofs that are in disrepair. A small portion of EPDM roof system that is questionable should be further tested by infrared analysis for wetness. Replacement of indicated shingled roof area (see drawings attached) above room #35.

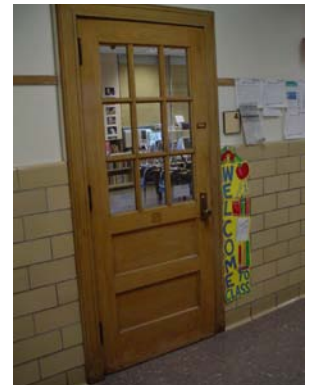
IN-01 Wood Doors:

Existing corridor doors, frames and glass transoms do not comply with code fire-rating requirements (1/3 hr.). Interior door hardware does not meet ADA requirements. Many corridor doors do not meet ADA pull side dimension requirements. Egress doors in vestibules and Multi-Purpose Room are 2'-6" wide and do not meet ADA guidelines. A select few doors at classrooms, which appear to have been added at a later date, do not have a 180-degree swing, and is not code compliant due to hindrance of egress corridor width. The doors at the 2002 additions meet requirements.

Replace non-complying fire-rated doors with 1/3 hr. rated complying doors, frames and hardware. Replace non-complying doors and door hardware with ADA complying widths and hardware. Replace glass transom panels with complying fire-rated glass.

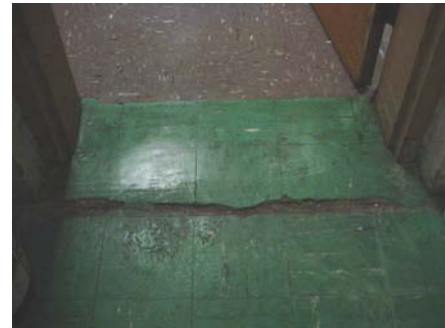
IN-02 Floor Tiles:

Certain rooms have 9" x 9" vinyl tiles in classrooms, which may be indicative of containing asbestos. The floor tiles at the 2002 additions appear to not contain asbestos.

Even though the tiles are non-friable, it is suggested that the Board have the tiles tested to ascertain if they contain asbestos. The Board may wish to have its abatement consultant prepare a schedule to remove any tile found to contain asbestos. This office will then provide the documents to replace the tile accordingly.

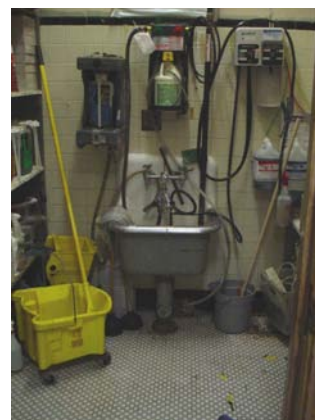
IN-03 Janitor Closets:

Janitor closets were found to be in poor conditions due to years of continuous hard use. The closets at the 2002 additions (where provided) appear clean and new.

Prep and paint all walls, floors and ceilings. Install new slop sinks/mop sinks and stainless steel equipment hanger strips and shelving.

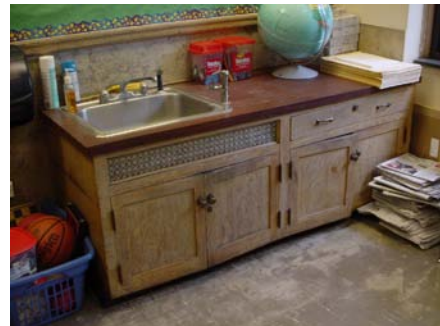
IN-04 Classroom Sink Cabinets and Counters:

The sink cabinets and counters in the classrooms were observed to be in poor condition from years of use. They also do not meet ADA requirements for height, sink lever handles and trim, insulated exposed piping, ADA approach requirements and D.O.E. bubbler/drinking fountain requirements (at Pre-K and Kindergartens). The classroom sink cabinets and counters at the 2002 additions meet requirements.

Replace all classroom sinks, sink cabinets and counters to meet ADA and code requirements.

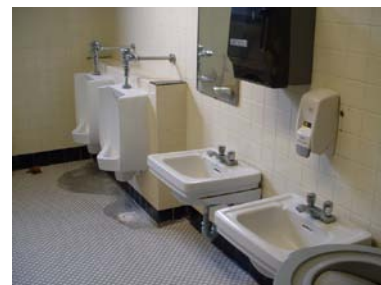
IN-05 Toilets:

One set of boys and girls' toilets in the original building near the main office does not meet ADA requirements. The other set of boys and girls' toilets in the rear of the building appears to have been renovated and an attempt to meet ADA guidelines is apparent, however, they do not. There is one uni-sex faculty toilet that meets ADA but the other one in the faculty workroom does not. New toilets in the 2002 Addition meet all requirements.

Renovate toilets with new fixtures, stalls, floor/wall/ceilings, accessories, etc., and reconfigure to meet ADA. Replace doors, frames and hardware. Update ventilation systems and lighting. Provide additional uni-sex toilets meeting ADA compliance to alleviate fixture count shortage due to larger ADA stalls.

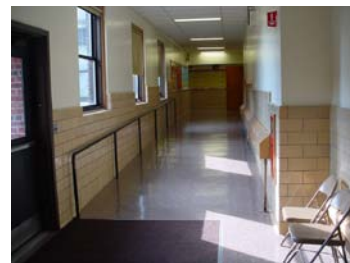
IN-06 Ramps:

Interior ramp handrails do not meet ADA requirements.

Provide new handrails that meet ADA requirements.

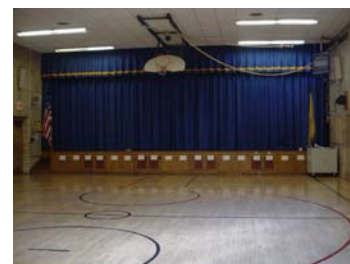
IN-07 Stage ADA Access:

No wheelchair access to the stage was observed. Second means of egress blocked by janitorial supplies, ladders, hand truck, etc.

Provide an ADA complying wheelchair lift to the stage floor from the Multi-Purpose Room floor. Remove items hindering second means of egress.

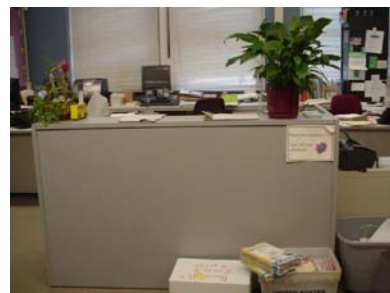
IN-09 Administration Area Reception Desk:

The Administration Desk does not provide for ADA wheelchair counter height.

Modify the Reception Area Desk to accommodate a 34" high counter area for the wheelchair disabled.

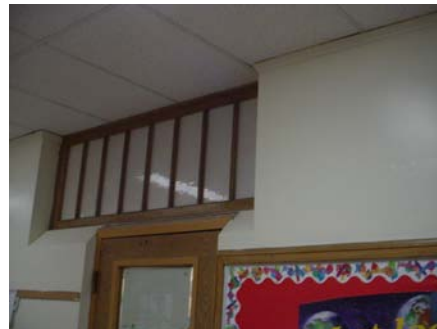
IN-11 Corridor Clearstory Windows:

Frame and glazing not fire-rated.

Replace with fire-rated frame and 1/4" wire glass.
