HARRISON ELEMENTARY SCHOOL

Livingston School District
Harrison Elementary School

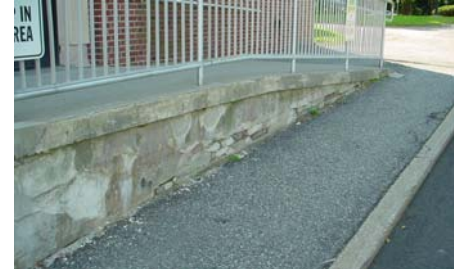
EX-01 Site:

The depressed curb drop at the east side of the 1929 building does not meet ADA. Concrete sidewalks and curbing are deteriorating and in need of replacement in some locations. The wall for the concrete ramp at the exterior of the east stair is crumbling. The asphalt at driveways, parking and play areas is cracking and there are no parking stall stripes, directional arrows or fire zone markings.

Install ADA complying depressed curb drops. Cut out broken, sunken and deteriorated sections of concrete walkways and concrete curbing. Replace the wall at the exterior concrete ramp adjacent to the east stair tower. Mill and resurface the drives, parking and play areas. Paint stripe parking bays, directional arrows and fire zone markings. Provide ADA directional signage for the ADA accessible access routes from the H.C. drop-off and parking stalls to the accessible building entrances. Reconstruct deteriorated concrete and masonry stairs.

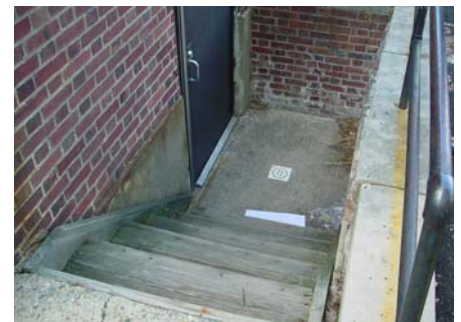
EX-02 Masonry Walls:

The exterior brickwork and limestone at the 1929 building is stained, cracked and broken with loose and missing joints. Doors and window lintels are rusting and peeling paint. The wrought iron balustrade above the main front building entrance is rusting and peeling paint. The wood fascias, soffits and trim are peeling paint with some areas cupping and warping due to water saturation. Aluminum leaders are bent and loose. There are no leader heads. Caulking at grills, windows and doors is drying and cracking. Control joints are missing caulking. The entire east elevation of the 2002 Gymnasium Addition has mortar splashing on the face brick. It appears the brick was not properly washed down after it was constructed. The wood stair at the rear of the 1929 building is rotting. Exterior stair railings are missing and not in ADA compliance. The exterior brick stairs on the rear of the 1929 building are cracking and deteriorating.

Replace broken and cracked brick. Cut out and repoint brick joints where loose, deteriorating and missing. Replace broken limestone. Cut out and repoint limestone joints. Clean all brick and limestone. Scrape and paint steel lintels at windows and doors. Scrape and paint the wrought iron balustrade above the main entrance. Scrape and paint wood fascias and trim. Replace aluminum leaders, providing leader heads and necessary base clean outs. Re-caulk perimeter of all grills, louvers, windows and doors. Install caulking at control joints, which is missing, and remove mortar splashings from the face brick on the entire east wall of the 2002 Gymnasium Addition. Remove the rotting wood stair at the rear of the 1929 building and replace with a new concrete stair. Replace non-ADA compliant handrails and provide new handrails at locations requiring same. Replace the cracking and deteriorating brick stairs with new concrete stairs at the rear of the 1929 building.

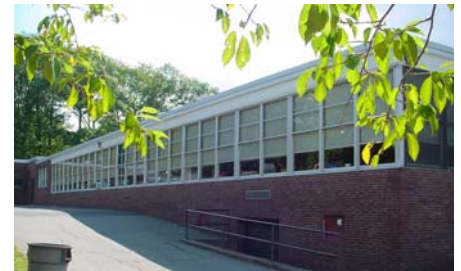
EX-03 Windows:

The double hung aluminum replacement windows at the 1929 building have insulated glazing and are in good condition, however, many windows show signs of worn and broken balances, resulting with the sash either sticking, unable to be raised or unable to stay in the open position. All other aluminum windows (except the 2002 Addition) are original, single glazed and non-insulating, in need of replacement.

Replace windows with new thermal break windows with 1" insulating glass at the South Wing, East Wing, Multi Purpose Room and original 1929 building.

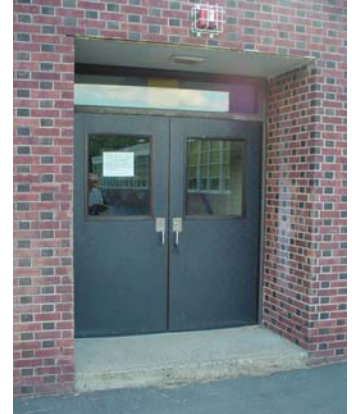
EX-04 Doors:

The doors, frame and transom at the main front entrance are in poor condition due to years of hard use. The doors do not have ADA compliant lever handles. All other exterior doors are FRP in hollow metal frames without lever handles on the exterior side. Certain doors are 2' – 6" wide, which do not meet the ADA required width. Existing metal frames appear in acceptable condition. The doors, frames and hardware in the 2002 Gymnasium Addition are in good condition and meet code requirements.

Replace the main entrance and foyer doors, frames and transoms. Replace FRP doors not meeting ADA required width. Replace all handles on exterior doors with lever handles. Clean existing metal frames and paint same. Replace all caulking at existing frames.

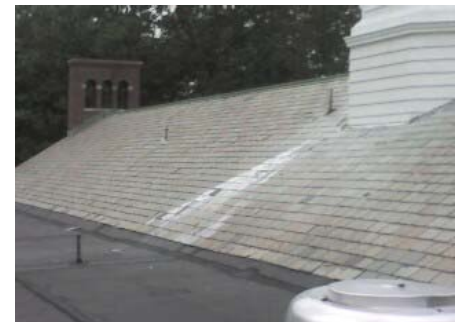
EX-05 Roofing:

The roofs at the latest additions are in good condition. Approximately 21,000 sf of EPDM and Carlisle flat roofs are very old and in poor condition. Other areas of flat roofs are starting to show signs of age and disrepair. The shingle roofs are in good condition for their age.

Replace the flat roofs that are in poor condition. The remaining 10,000 sf of flat roofs should be further investigated, again through infrared testing to look for signs of wetness. The shingle roofs are nearing the end of their lifecycle and will need to be replaced within the next 5 years.

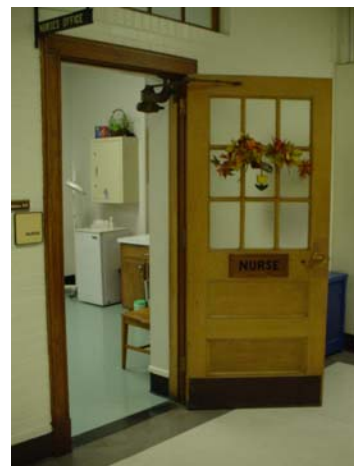
IN-01 Wood Doors:

The 1929 building is sprinklered, therefore, corridor doors, frames and transoms (other than stair towers) need not be fire-rated. Most doors in the 1929 building have been retrofitted with lever hardware, however some doors were found with knob handles. Some doors were found to not be in compliance with the ADA 18" unobstructed pull side requirement. In the other building additions (except the 2002 Addition) corridor doors and frames were found not to be rated, toilet doors had louvers, corridor doors without wire glass, door widths 2' – 6" and doors not in compliance with the ADA 18" clear pull side requirements.

Replace non-complying door handles with complying ADA lever handles. Modify masonry opening and provide new doors and frames at non-complying ADA pull side doors. Replace non-complying corridor doors with 1/3 hour rated, complying doors and frames. Note: Fire-rating not required for doors and frames in sprinklered areas. Replace corridor doors which have louvers in them. Close up transoms in corridor walls. Install new fire-rated doors, transoms, frames and hardware at stair tower corridor doorways.

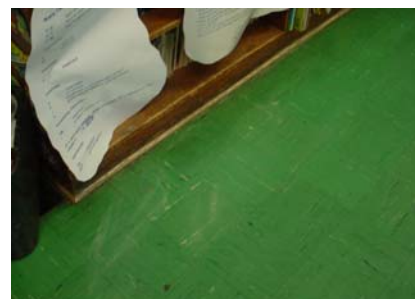
IN-02 Floor Tiles:

Certain rooms have 9" x 9" vinyl tiles in classrooms, which may be indicative of containing asbestos.

Even though the tiles are non-friable, it is suggested that the Board have the tiles tested to ascertain if they contain asbestos. This office will then provide the documents to replace the tile accordingly.

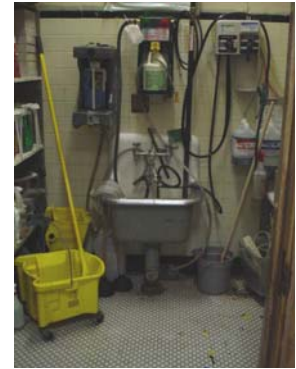
IN-03 Janitor Closets:

Janitor closets were found to be in poor conditions due to years of continuous hard use.

Prep and paint all walls, floors and ceilings. Install new slop sinks/mop sinks and stainless steel equipment hanger strips and shelving.

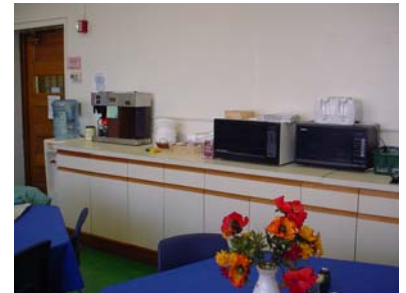
IN-04 Sink, Cabinets and Counters:

The sink, cabinets and counters in the Faculty Room are not ADA compliant.

Replace the sink, sink cabinet and counter to meet ADA and code requirement.

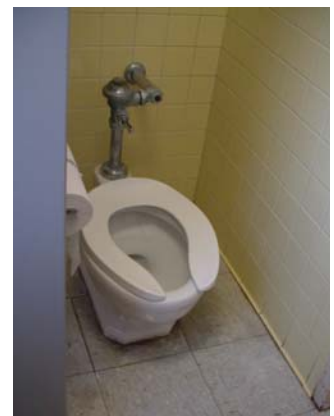
IN-05 Toilets:

The boys' toilets in the 1929 building do not meet ADA requirements. All classroom toilets do not meet ADA requirements. Some toilets have new wall, floor and ceiling finishes and new stalls. Some toilets have outdated fixtures, stalls and accessories. The 2002 Addition toilets meet all ADA requirements.

Renovate toilets not meeting ADA requirements. Renovate toilets, which do not have new floor, walls and ceiling finishes, fixtures, stalls and accessories. Update ventilation systems and lighting. Provide additional uni-sex toilets meeting ADA compliance to alleviate fixture count shortage due to larger ADA stalls.

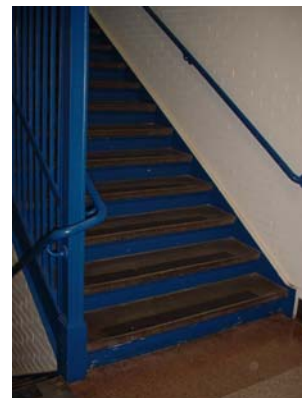
IN-06 Stair Towers:

Handrails do not have ADA compliant extensions. Treads have non-slip nosings. Metal door frames and transoms at corridors are not fire-rated. Doors do not have latchable lever handles.

Install new ADA compliant handrails with extensions. Install new fire-rated doors, transoms, frames and code complying hardware at corridor doorways. Note: Stair tower doors at basement need to be replaced.

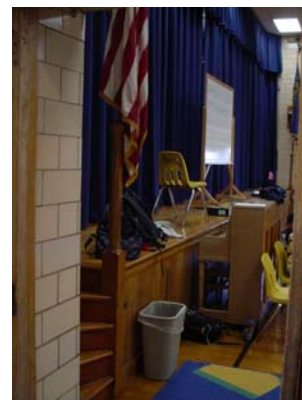
IN-07 Stage ADA Access:

No wheelchair access to the stage was observed.

Provide an ADA complying wheelchair lift to the stage floor from the Multi-Purpose Room floor.

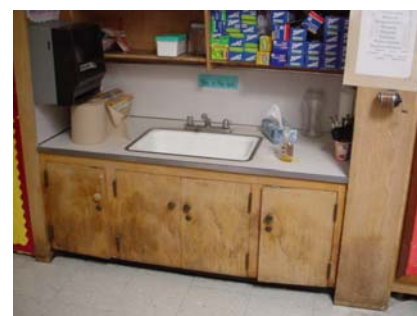
IN-08 Classroom Sink Cabinets and Counters:

The sink cabinets and counters in the classrooms were observed to be in poor condition from years of use. They also do not meet ADA requirements for height, sink lever handles and trim, insulated exposed piping, ADA approach requirements and D.O.E. bubbler/drinking fountain requirements (at Pre-K and Kindergartens).

Replace all classroom sinks, sink cabinets and counters to meet ADA and code requirements.

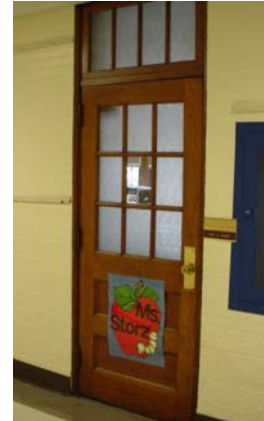
IN-09 Building Signage:

Room signage was either missing, non-informative as to correct room use and not ADA compliant at the second floor.

Install a uniform ADA compliant signage system, coordinated with the present construction program.

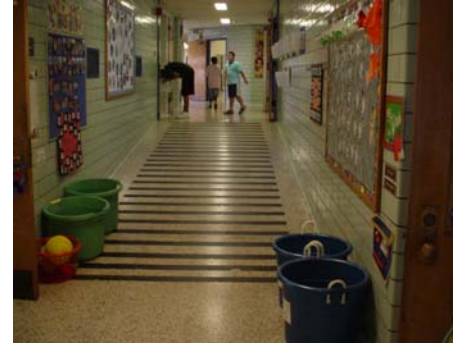
IN-12 Corridor Ramps:

Corridors have ramps without ADA compliant handrails.

Install ADA compliant handrails at all corridor ramps.

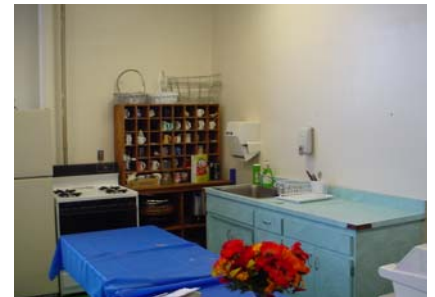
IN-13 Teacher Room Gas Range:

There is no hood or fire suppression system at the gas range.

Provide a ventilated hood with fire suppression system over the gas range.

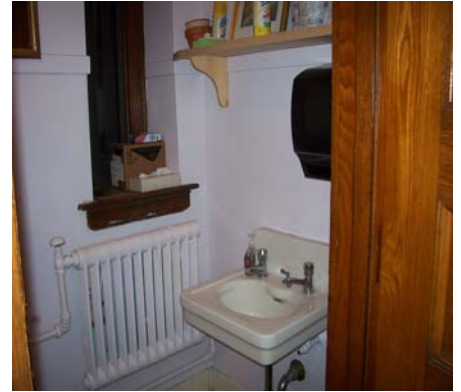
IN-16 Nurse's Toilet:

Toilet room not ADA compliant.

Make toilet room ADA compliant.
