## **RIKER HILL ELEMENTARY SCHOOL**

### **Overview:**

Livingston School District  
Riker Hill Elementary School

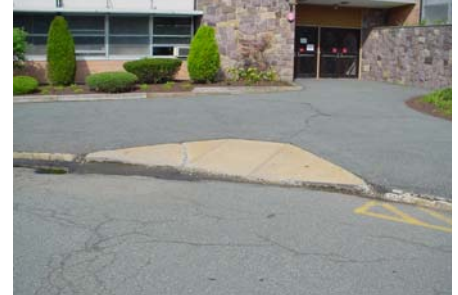
### EX-01 Site:

Asphalt parking areas are cracked, sinking and breaking up. Existing striping and directional arrows are fading and hard to see. Concrete sidewalks and curbing are deteriorating and in need of replacement in some locations.

*Mill and resurface the cracked, sinking and breaking up drives and parking areas. Paint stripe parking bays, directional arrows and fire zone markings. Cut out and replace broken, sunken and deteriorated sections of concrete walkways and concrete curbing. Provide ADA complying handrails at the exterior ramps for barrier free access to main entrance.*

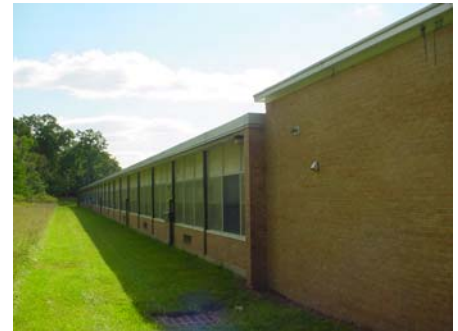
### EX-02 Masonry Walls:

The exterior of the older building is a one-story full height brick-faced masonry wall. The brick masonry appears in good condition with no major cracking noticed. Some localized opened masonry joints were noticed. Caulking at doors, windows and louvers is dried out and cracking. The masonry walls at the 2002 additions are in good condition.

*Even though no water infiltration was observed inside the building, spot masonry joint cut and pointing should be performed. Also, doors, windows and louvers should be re-caulked. No work at the 2002 additions is necessary.*

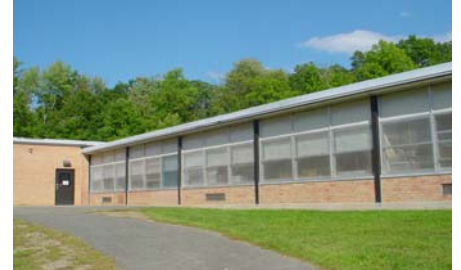
### **EX-03 Windows:**

Exterior walls have original full height aluminum windows, which are single glazed, non-thermal break and energy inefficient. The 2002 addition windows are new, thermal efficient and in good condition.

*Replace the original windows with new thermal break windows with 1" thick insulating glass.*

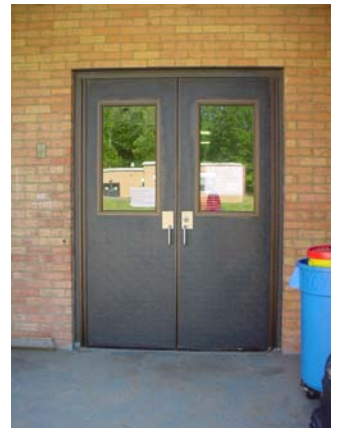
### **EX-04 Doors:**

Exterior doors are FRP, without lever handles on the exterior side. Certain doors are 2' - 6" in width, which do not meet the ADA required width. Existing metal frames appear in acceptable condition. The doors, frames and hardware at the 2002 additions are in good condition.

*Replace FRP doors not meeting ADA required width. Replace all hardware on exterior doors with lever handles. Clean existing metal frames and paint same. Replace all caulking at existing frames.*

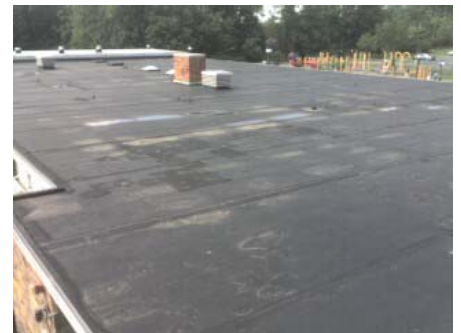
### **EX-05 Roofing:**

The built up roofs on the latest additions are new and in good condition, no repairs are required. Approximately 11,000 sf of EPDM roofs have exceeded their life span and are in poor condition. The remaining EPDM roofs are nearing the end of their life cycle and require further investigation.

*Replace the EPDM roofs in disrepair. The remainder should undergo infrared testing to determine areas of wetness and/or dampness.*

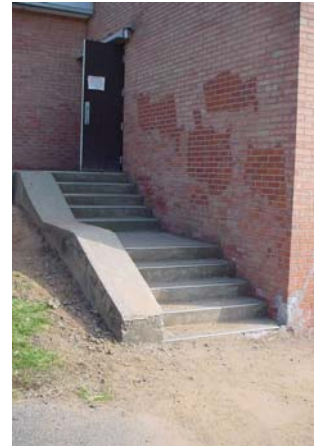
### **EX-06 Exterior Concrete Step at Activity Room:**

Step and platform need replacement.

*Replace step and platform.*

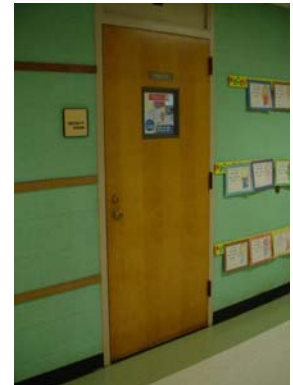
#### **IN-01 Wood Doors:**

Certain corridor doors do not comply with code fire-rating requirements (1/3 hr.). Corridor door hardware and push/pull hardware do not comply with ADA requirements. Certain doors have louvers in transom panels without fire dampers. Many corridor doors do not meet ADA pull side dimension requirements. Main office corridor glass wall does not comply with corridor hourly rating requirements. The doors at the 2002 additions meet requirements.

*Replace non-complying fire-rated doors with 1/3 hr. rated complying doors and hardware. Replace non-complying door hardware with ADA complying hardware. Replace transom panel louvers with complying fire dampered louvers. Modify masonry opening and provide new doors and frames at non-complying ADA pull side doors. Provide new corridor glass wall at Main Office meeting 1/3 hr. fire-rating and code glass area requirements.*

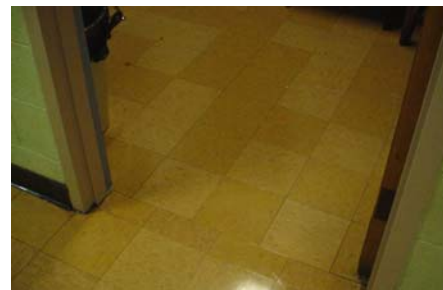
### **IN-02 Floor Tiles:**

Certain rooms have 9" x 9" vinyl tiles in classrooms, which may be indicative of containing asbestos. The floor tiles at the 2002 additions appear to not contain asbestos.

*Even though the tiles are non-friable, it is suggested that the Board have the tiles tested to ascertain if they contain asbestos. The Board may wish to have its abatement consultant prepare a schedule to remove any tile found to contain asbestos. This office will then provide the documents to replace the tile accordingly.*

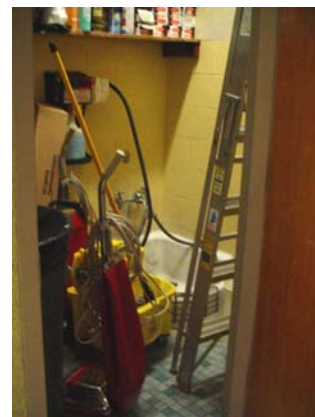
### **IN-03 Janitor Closets:**

Janitor closets were found to be in poor conditions due to years of continuous hard use. The closets at the 2002 additions (where provided) appear clean and new.

*Prep and paint all walls, floors and ceilings. Install new slop sinks/mop sinks and stainless steel equipment hanger strips and shelving.*

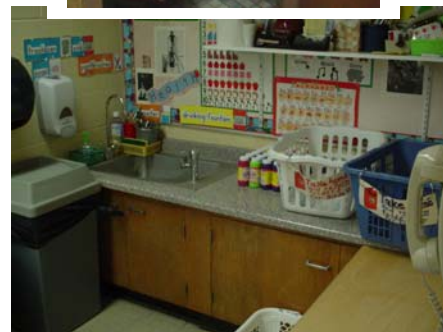
### **IN-04 Classroom Sink Cabinets and Counters:**

The sink cabinets and counters in the classrooms were observed to be in poor condition from years of use. They also do not meet ADA requirements for height, sink lever handles and trim, insulated exposed piping, ADA approach requirements and D.O.E. bubbler/drinking fountain requirements (At pre-K and Kindergartens). The classroom sink cabinets and counters at the 2002 additions meet requirements.

*Replace all classroom sinks, sink cabinets and counters to meet ADA and code requirements.*

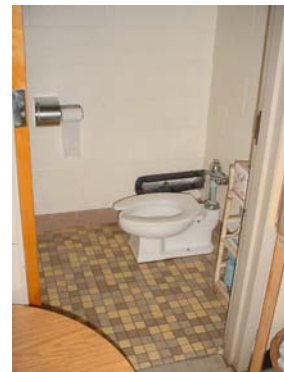
### **IN-05 Toilets:**

One set of boys and girls' toilets in the building meets ADA requirements except for insulation on the exposed sink piping. The other set of boys and girls' toilets does not meet ADA requirements. None of the toilets within the classrooms meet ADA requirements. The faculty toilets do not meet ADA requirements. All toilets have outdated fixtures, stalls and accessories. Nurse's toilet area does not meet ADA requirements.

*Renovate all toilets with new fixtures, stalls, floor/wall/ceilings, accessories, etc. Replace doors, frames and hardware. Update ventilation systems and lighting. Provide additional uni-sex toilets meeting ADA compliance to alleviate fixture count shortage due to larger ADA stalls.*

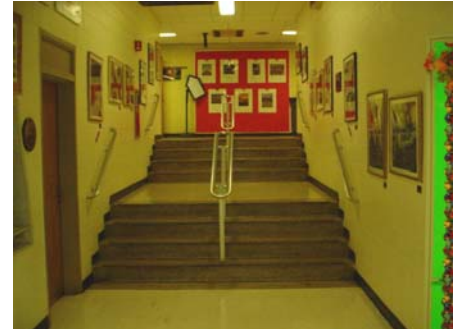
**IN-08 ADA Access to West Building Wing:**

There is only stair access to the West Wing from the main building entrance foyer. No vertical lift for the disabled is provided.

*Modify stairs and provide a vertical access wheelchair lift from the existing building entrance foyer level to the West Wing floor level. See Report Section 12. Provide new stair railings to meet ADA requirements.*

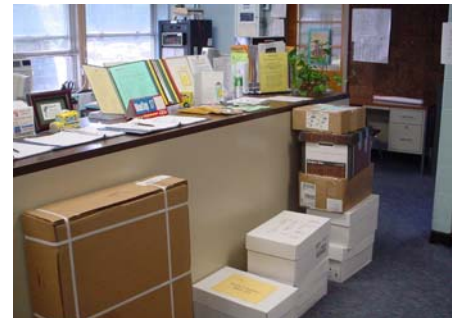
**IN-09 Administration Area Reception Desk:**

The Administration Desk does not provide for ADA wheelchair counter height.

*Modify the Reception Area Desk to accommodate a 34" high counter area for the wheelchair disabled.*
