HERITAGE MIDDLE SCHOOL

Livingston School District
Heritage Middle School

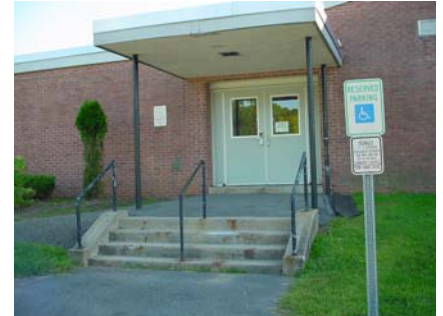
EX-01 Site:

Belgian block curbing is loose in some areas. Concrete walks and steps are deteriorating and in need of replacement in some locations. Asphalt parking areas, driveways and walks are cracked and broken. Existing striping, directional arrows and fire zone markings are fading and hard to see.

Replace loose Belgian block curbing. Cut out and replace cracked, broken and deteriorated sections of concrete walks. Replace cracked and broken concrete stairs. Provide ADA complying handrails at exterior stairs. Mill and resurface parking areas, driveways and walks which are cracked and broken. Paint stripe parking bays, directional arrows and fire zone markings.

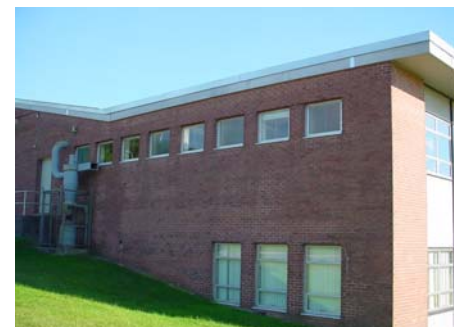
EX-02 Masonry Walls:

The brick masonry appears in good condition with no major cracking noticed. The brickwork at the bottom of the window walls is stained and streaked. Caulking at doors, windows, grills and louvers is dried out and cracking. The masonry walls at the 2002 additions are in good condition.

Even though no water infiltration was observed coming through the masonry walls, any open masonry joints should be cut back and pointed. Clean stains and streaked brick work at base of window walls. Re-caulk doors, windows, and louvers.

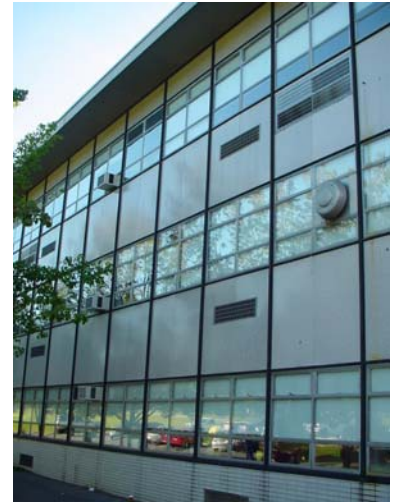
EX-03 Windows:

Exterior walls have original full height aluminum curtain walls, which are single glazed, non-thermal break and energy inefficient. The windows in the 2002 additions are new, thermal efficient and in good condition.

Replace the original windows with new thermal break windows having 1" thick insulating glass at the North Wing, South East and Media Center.

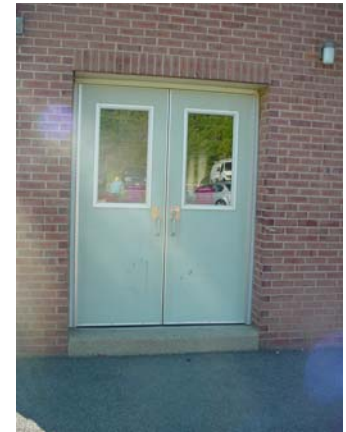
EX-04 Doors:

Exterior doors are FRP, without lever handles on the exterior side. Existing metal frames appear in acceptable condition. The doors, frames and hardware at the 2002 additions are in good condition.

Replace FRP doors not meeting ADA required width. Replace all hardware on exterior doors with lever handles. Clean existing metal frames and paint same. Replace all caulking at existing frames.

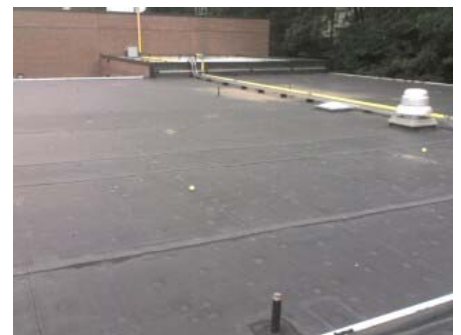
EX-05 Roofing:

The built-up and shingle roofs at the latest building additions are new and in good condition. The indicated EPDM roof areas and the sole Hypalon roof area are in poor condition with blistering, wrinkling and field seams failures.

Replace the roofing in the areas that are in disrepair.

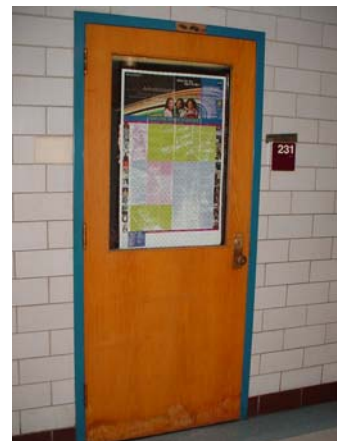
IN-01 Wood Doors:

Certain corridor doors do not comply with code fire-rating requirements (1/3 hr.) Corridor door hardware and push/pull hardware do not comply with ADA requirements. Certain doors have louvers in transom panels without fire dampers. Many corridor doors do not meet ADA pull side dimension requirements. Main Office corridor glass wall does not comply with corridor hourly rating requirements. The doors at the 2002 additions meet requirements.

Replace non-complying fire-rated doors with 1/3 hr. rated complying doors and hardware. Replace non-complying door hardware with ADA complying hardware. Replace transom panel louvers with complying fire-dampened louvers. Modify masonry opening and provide new doors and frames at non-complying ADA pull side doors. Provide a new corridor glass wall at Main Office meeting 1/3 hr. fire-rating and code glass area requirements.

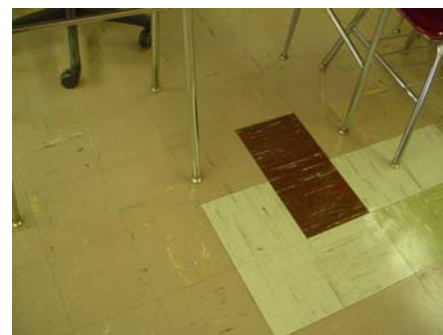
IN-02 Floor Tiles:

Certain rooms have 9" x 9" vinyl tiles in classrooms, which may be indicative of containing asbestos. The floor tiles at the 2002 additions appear to not contain asbestos.

Even though the tiles are non-friable, it is suggested that the Board have the tiles tested to ascertain if they contain asbestos. The Board may wish to have its abatement consultant prepare a schedule to remove any tile found to contain asbestos. This office will then provide the documents to replace the tile accordingly.

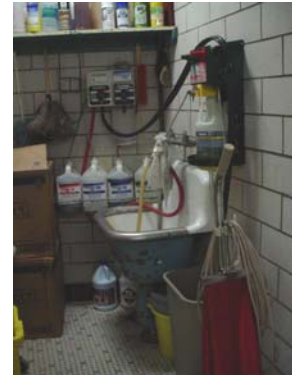
IN-03 Janitor Closets:

Janitor closets were found to be in poor condition due to years of continuous hard use. The closets at the 2002 additions (where provided) appear clean and new.

Prep and paint all walls, floors and ceilings. Install new slop sinks/mop sinks and stainless steel equipment hanger strips and shelving.

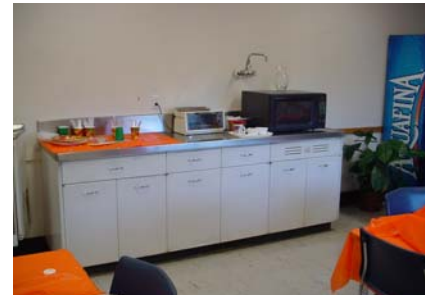
IN-04 Sink, Cabinets and Counter:

The sink, cabinets and counter in the Faculty Room are not ADA compliant.

Replace the sink, cabinets and counter to meet ADA and code requirement.

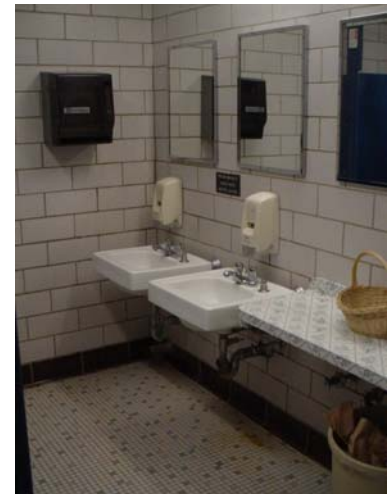
IN-05 Toilets:

The public toilets do not meet ADA requirements. All classroom toilets do not meet ADA requirements. Some toilets have new wall, floor and ceiling finishes and new stalls. Some toilets have outdated fixtures, stalls and accessories. No insulation on exposed pipes below sinks. The 2002 addition toilets meet all ADA requirements.

Renovate toilets not meeting ADA requirements. Renovate toilets, which do not have new floors, walls and ceiling finishes, fixtures, stalls, and accessories. Install insulation on exposed piping below sinks. Update ventilation systems and lighting. Provide additional uni-sex toilets meeting ADA compliance to alleviate fixture count shortage due to larger ADA stalls.

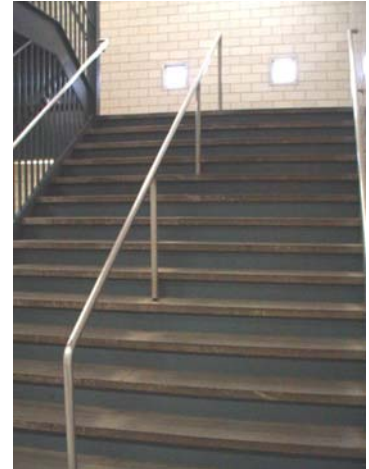
IN-06 Stair Towers:

Handrails do not have ADA compliant extensions. Metal door frames and transoms at corridors are not fire-rated. Doors do not have latchable lever handles. Stairway treads are not slip resistant. Handrails are not ADA compliant. Non-structural cracks in terrazzo flooring.

Install new ADA compliant handrails with extensions. Install new fire-rated doors, transoms, frames and code complying hardware at corridor doorways. Install slip resistant nosings. Repair cracked terrazzo flooring.

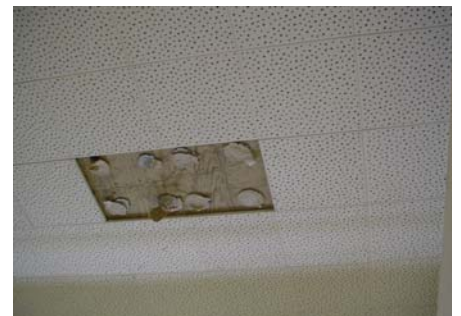
IN-07 Acoustical Tile Ceilings:

Most acoustical tile ceiling panels are showing signs of warping due to humidity and discoloring due to age. In corridor ceilings some panels are water stained. Glued down 12" x 12" ceiling tiles in classrooms are old and in poor condition.

Replace all warped, discolored and stained acoustical ceiling tiles in corridors and cafeteria. Reinstall corridor and cafeteria light fixtures. Replace 12" x 12" glued down ceiling tiles in classrooms. Replace classroom light fixtures.

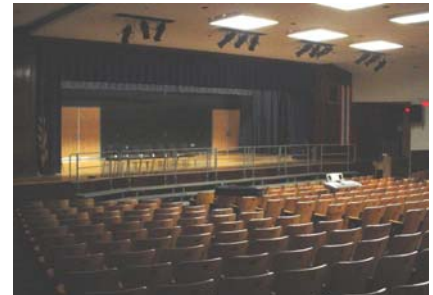
IN-08 Auditorium:

The auditorium does not have provisions for handicap seating in accordance with ADA requirements. There is no handicap lift access to the stage. The flooring is non-acoustical 9x9 vinyl tile. The seats are the original wood chairs. The auditorium appears to be lacking modern acoustical sound treatments.

Renovate and upgrade entire Auditorium. Provide handicap seating and hearing devices conforming to ADA requirements. Provide a handicap lift for access to the stage. Replace the vinyl flooring tiles with carpeting. Replace the original wood chair seating with modern upholstered seating. Provide acoustical sound treatments to the auditorium surfaces. Provide new sound system and lighting. Provide new stage lighting. Provide new acoustical ceiling. Provide air conditioning. Provide new stage curtains.

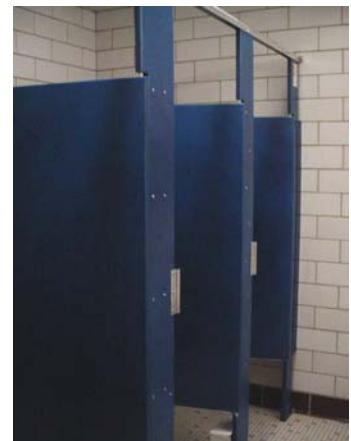
IN-9 Gym Locker Rooms:

Toilets do not comply with ADA requirements.

Renovate the toilets to comply with ADA requirements for toilet stalls, toilets, accessories, sinks and urinals.

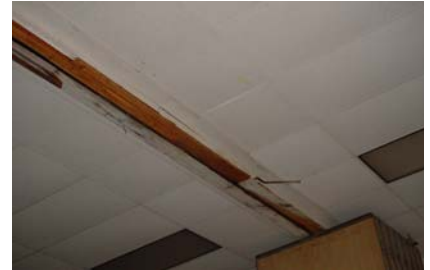
IN-10 Cafeteria Moveable Partition:

The moveable partition is original and in need of replacement.

Replace the moveable partition.
