HILLSIDE ELEMENTARY SCHOOL

Livingston School District
Hillside Elementary School

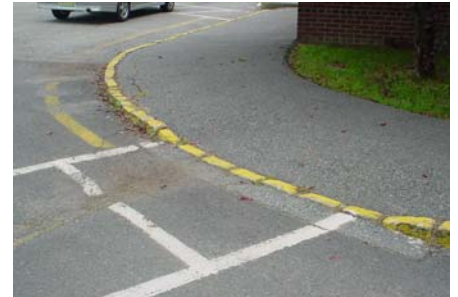
EX-01 Site:

Asphalt parking areas are cracked and breaking up. Existing striping and directional arrows are fading and hard to see. Concrete sidewalks and curbing are deteriorating and in need of replacement in some locations.

Mill and resurface cracked and breaking up drives and parking areas. Paint stripe parking bays, directional arrows and fire zone markings. Cut out broken, sunken and deteriorated sections of concrete walkways and concrete curbing. Provide ADA complying handrails at the exterior ramps for barrier-free access to main entrance.

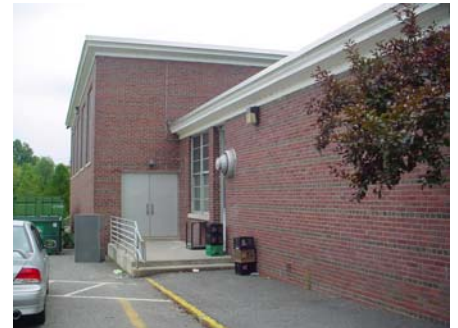
EX-02 Masonry Walls:

The exterior of the older building is a two-story, full height, brick faced masonry wall. The brick masonry appears in good condition with no major cracking noticed. A few areas of graffiti removal were observed. Some localized opened masonry joints were noticed. Caulking at original doors, windows and louvers is dried out and cracking. The masonry walls at the 2002 additions are in good condition.

Even though no water infiltration was observed inside the building, spot masonry joint cut and pointing should be performed. Also, doors, windows and louvers should be re-caulked. No work at the 2002 additions is necessary.

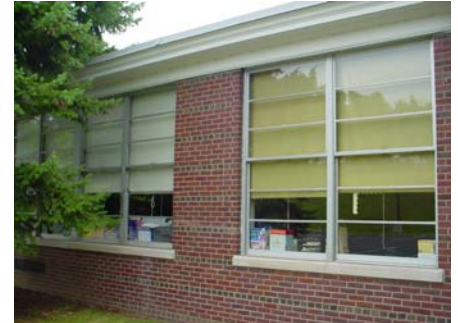
EX-03 Windows:

Exterior walls have original full height aluminum windows, which are single glazed, non-thermal break and energy inefficient. The 2002 Addition windows are new, thermal efficient and in good condition.

Replace the original windows with new thermal break windows with 1" thick insulating glass at the Multi Purpose Room, Gymnasium, Upper West Wing and Stairs.

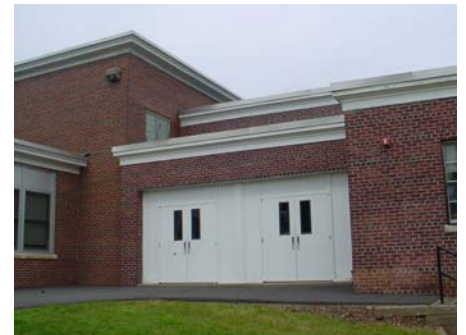
EX-04 Doors:

Exterior doors are aluminum or hollow metal, without lever handles on the exterior side. Existing metal frames appear in acceptable condition. The doors, frames and hardware at the 2002 additions are in good condition.

Replace existing doors with FRP doors. Replace all hardware on exterior doors with lever handles. Clean existing metal frames and paint same. Replace all caulking at existing frames.

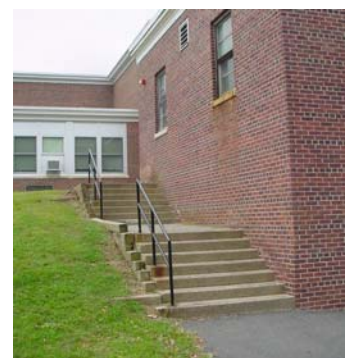
EX-05 Stairs:

Exterior stairs lack non-slip nosings and handrails do not meet ADA requirements.

Replace stair nosings and handrails.

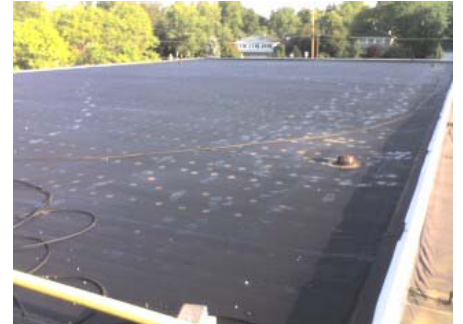
EX-06 Roofing:

The built up roof areas on the latest additions are new and in good condition, no repairs are required. The remainder of the EPDM roofs require further investigation.

Roofs requiring further investigation should have infrared testing done to establish any wet and/or damp areas

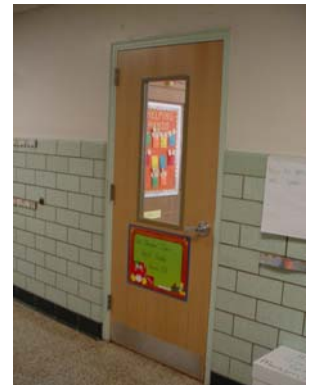
IN-01 Wood Doors:

Certain corridor doors and glass transoms do not comply with code fire-rating requirements (1/3 hr.). Corridor door hardware meets ADA requirements except for a select few. The doors at the 2002 additions meet requirements. Doors in kitchen area are 2' – 6" wide. Note: Majority have been replaced to meet code. Eleven doors took exception to designated label and need to be replaced. Also, two pairs of doors at Multi-Purpose Room need (1) hr. "B" label, not 1/3 hr. label.

Replace non-complying fire-rated doors with 1/3 hr. rated complying doors and hardware. Replace non-complying door hardware with ADA complying hardware. Replace glass transom panels with complying fire rated glass.

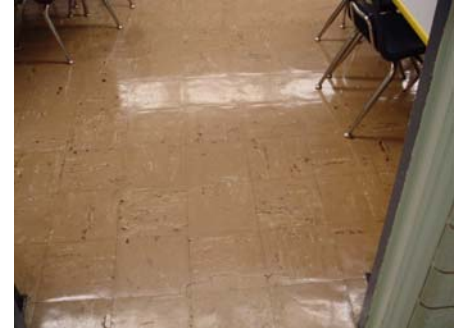
IN-02 Floor Tiles:

Certain rooms have 9" x 9" vinyl tiles in classrooms, which may be indicative of containing asbestos. The floor tiles at the 2002 additions appear to not contain asbestos.

Even though the tiles are non-friable, it is suggested that the Board have the tiles tested to ascertain if they contain asbestos. The Board may wish to have its abatement consultant prepare a schedule to remove any tile found to contain asbestos. This office will then provide the documents to replace the tile accordingly.

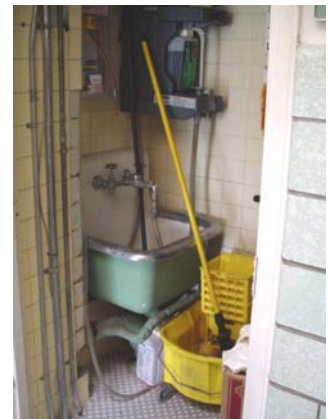
IN-03 Janitor Closets:

Janitor closets were found to be in poor conditions due to years of continuous hard use. The closets at the 2002 additions (where provided) appear clean and new.

Prep and paint all walls, floors and ceilings. Install new slop sinks/mop sinks and stainless steel equipment hanger strips and shelving.

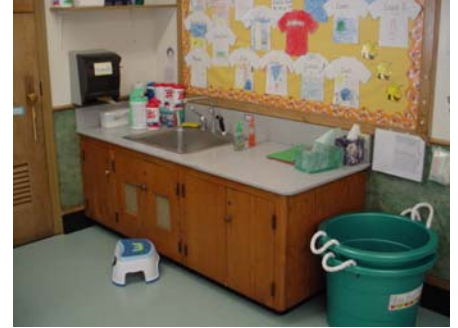
IN-04 Classroom Sink Cabinets and Counters:

The sink cabinets and counters in the classrooms were observed to be in poor condition from years of use. They also do not meet ADA requirements for height, sink lever handles and trim, insulated exposed piping, ADA approach requirements and D.O.E. bubbler/drinking fountain requirements (at Pre-K and Kindergartens). The classroom sink cabinets and counters at the 2002 additions meet requirements.

Replace all classroom sinks, sink cabinets and counters to meet ADA and code requirements.

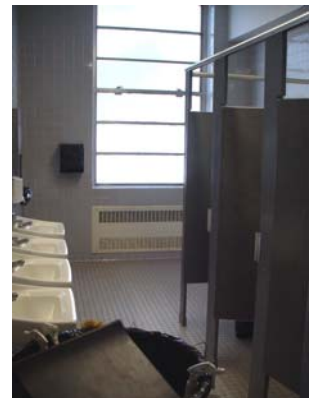
IN-05 Toilets:

One set of boys and girls' toilets on the first floor in the building meets ADA requirements. The other set of boys and girls' toilets on the lower level does not meet ADA requirements although signage indicates it does. None of the toilets within the classrooms meet ADA requirements. There is one uni-sex faculty toilet, which meets ADA but the remainder do not.

Renovate faculty toilets with new fixtures, stalls, floor/wall/ceilings, accessories, etc. Reconfigure lower level toilets to meet ADA. Replace doors, frames and hardware. Update ventilation systems and lighting. Provide additional uni-sex toilets meeting ADA compliance to alleviate fixture count shortage due to larger ADA stalls.

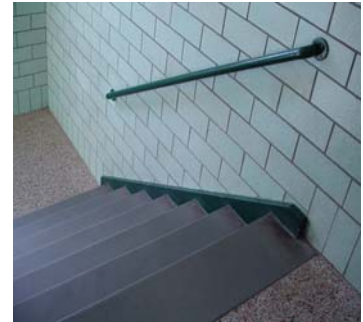
IN-06 Stairwells:

Interior stair treads lack non-slip nosings. Handrails do not meet ADA requirements. Terrazzo cracked.

Provide new non-slip nosings and new handrails that meet ADA requirements. Repair cracked terrazzo.

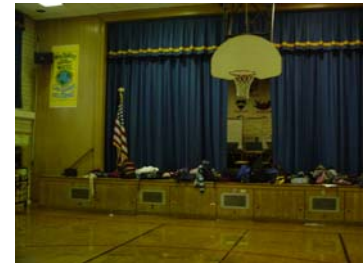
IN-07 Stage ADA Access:

No wheelchair access to the stage was observed.

Provide an ADA complying wheelchair lift to the stage floor from the Multi-Purpose Room floor.

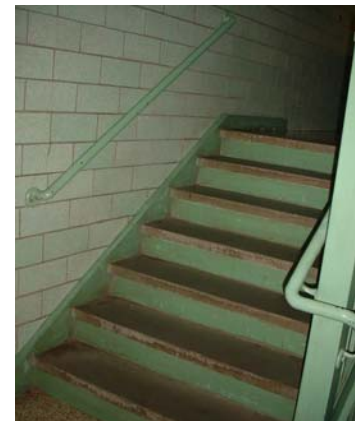
IN-08 ADA Access to Lower Level:

There is only stair access to the Lower Level from the building's First Floor Level. No elevator for the disabled is provided.

Provide a new elevator to allow access to the Lower Level for the disabled. See Report Section 10.

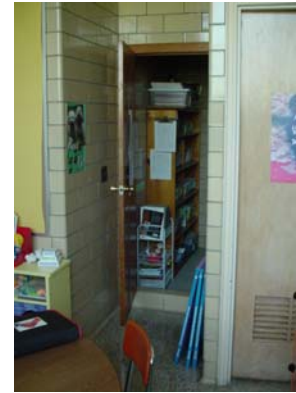
IN-09 Room #106 Reading Room:

Adjacent door in room has a raised lip at the door sill.

Lip needs to be removed.

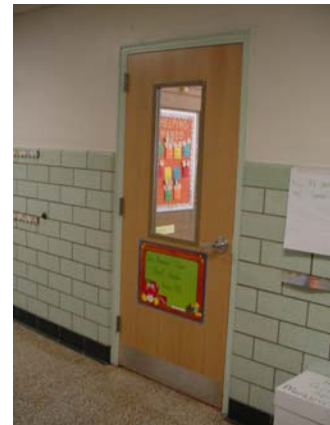
IN-11 Classroom Signage:

There are no classroom signs.

Install ADA compliant signs.

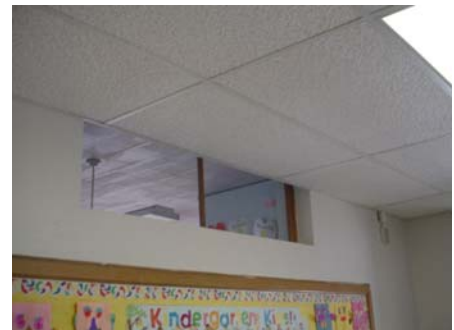
IN-12 Corridor Clearstory Windows:

Frame and glazing not rated.

Replace with fire-rated frame and 1/4" wire glass.

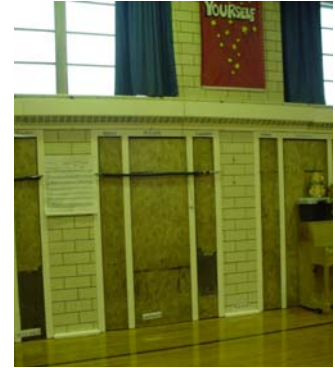
IN-13 Multi-Purpose Room Tables:

Cafeteria tables are built into walls.

Remove built-in cafeteria tables and close in void in wall.
