MOUNT PLEASANT ELEMENTARY SCHOOL

Livingston School District
Mount Pleasant Elementary School

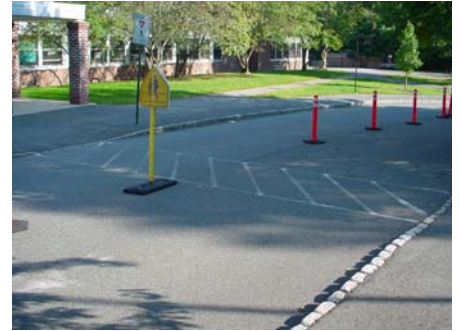
EX-01 Site:

Concrete walks and platforms are deteriorating and in need of replacement in some locations. Asphalt parking areas, driveways and walks are cracked and broken. Existing striping, directional arrows and fire zone markings are fading and hard to see.

Cut out and replace cracked, broken and deteriorated sections of concrete walks and platforms. Replace cracked and broken concrete stairs. Provide ADA complying handrails at exterior stairs. Mill and resurface parking areas, driveways and walks, which are cracked and broken. Paint stripe parking bays, directional arrows and fire zone markings. Provide ADA compliant directional signage indicating handicapped accessible routes.

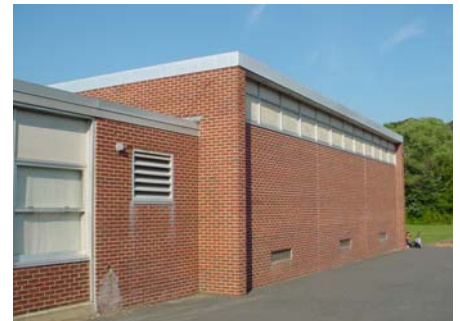
EX-02 Masonry Walls:

The brick masonry appears in good condition with no major cracking noticed. Caulking at doors, windows, grills and louvers is dried out and cracking. The masonry walls at the 2002 additions are in good condition.

Even though no water infiltration was observed coming through the masonry walls, any open masonry joints should be cut and pointed. Re-caulk doors, windows and louvers.

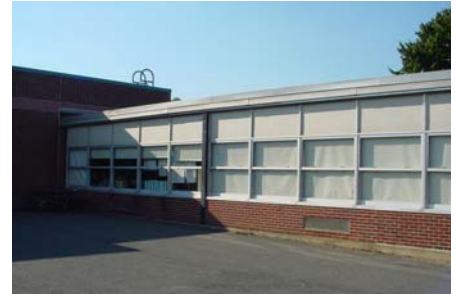
EX-03 Windows:

Exterior walls have original aluminum windows, which are single glazed, non-thermal break and energy inefficient. The windows at the 2002 additions are new, thermal efficient and in good condition.

Replace the original aluminum windows with new thermal break aluminum windows having 1" thick insulating glass at the Courtyard "A", Courtyard "B", Rear Elevation and Activity Room.

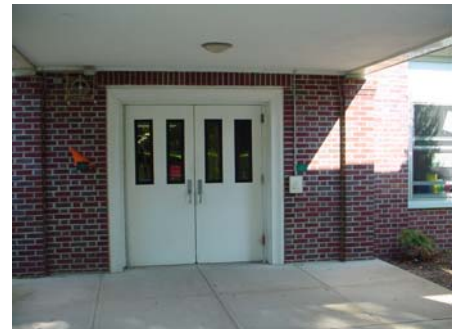
EX-04 Doors:

Exterior doors are FRP, without lever handles on the exterior side. Certain doors are 2' - 6" in width, which do not meet the ADA required width. Existing metal frames appear in acceptable condition. The doors, frames and hardware at the 2002 additions are in good condition. Note: Courtyard "B" door and 12' x 8' frame must swing out and door and frame assembly be replaced.

Replace FRP doors not meeting ADA required width. Replace all hardware on exterior doors with lever handles. Clean existing metal frames and paint same. Replace all caulking

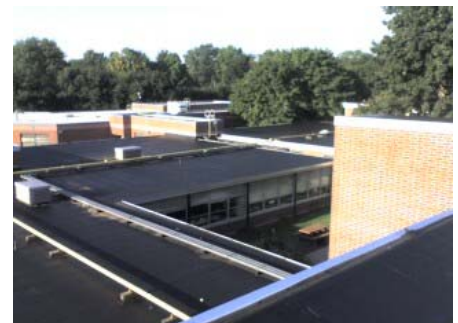
EX-05 Roofing:

The built-up roofs at the latest addition are new and in good condition. The remaining EPDM roofs are in poor condition with bubbles and seams failing.

Replace the EPDM roofs that are in disrepair, approximately 43,000 sf.

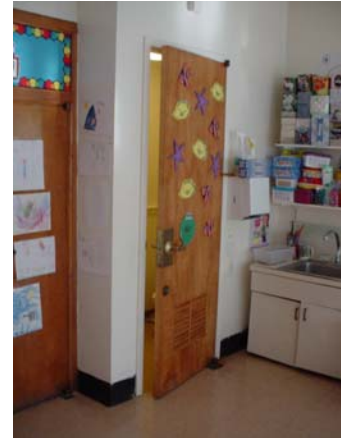
IN-01 Wood Doors:

Certain corridor doors do not comply with code fire-rating requirements (1/3 hr.) Corridor door hardware and push/pull hardware do not comply with ADA requirements. Certain doors have louvers in transom panels without fire dampers. Many corridor doors do not meet ADA pull side dimension requirements. The doors at the 2002 additions meet requirements.

Replace non-complying fire-rated doors with 1/3 hr. rated complying doors and hardware. Replace non-complying door hardware with ADA complying hardware. Replace transom panel louvers with complying fire dampered louvers. Modify masonry opening and provide new doors and frames at non-complying ADA pull side doors.

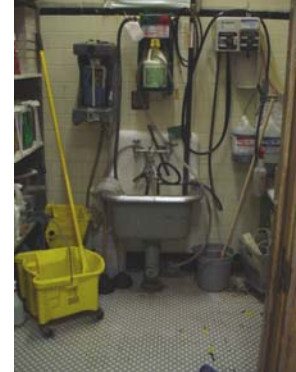
IN-03 Janitor Closets:

Janitor closets were found to be in poor condition due to years of continuous hard use. The closets at the 2002 additions (where provided) appear clean and new.

Prep and paint all walls, floors and ceilings. Install new slop sinks/mop sinks and stainless steel equipment hanger strips and shelving.

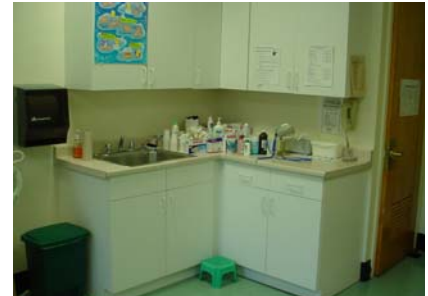
IN-04 Sink, Cabinets and Counters:

The sink, cabinets and counters in the classrooms are not ADA compliant.

Replace the sink, sink cabinets and counters to meet ADA and code requirement.

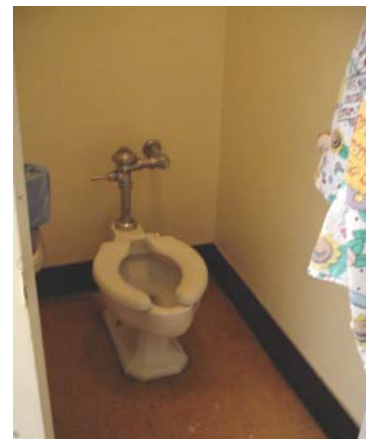
IN-05 Toilets:

Classroom toilets do not meet ADA requirements. Some toilets have new wall, floor and ceiling finishes and new stalls. Some toilets have outdated fixtures, stalls and accessories. No insulation on exposed pipes below sinks. The 2002 addition toilets meet all ADA requirements.

Renovate toilets not meeting ADA requirements. Install insulation on exposed piping below sinks. Update ventilation systems and lighting.

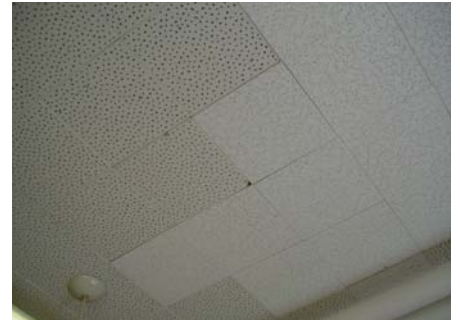
IN-06 Acoustical Tile Ceiling:

Most acoustical tile ceiling panels are showing signs of warping due to humidity and discoloring due to age. Some panels are water stained.

Replace all warped, discolored and stained acoustical tile-ceiling tiles. New light fixtures.

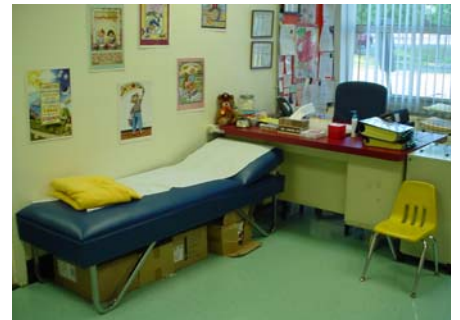
IN-07 Nurse's Office:

The Nurse's office does not meet ADA requirements for doors, hardware and toilet room.

Provide new uni-sex toilet room meeting all ADA requirements, new doors and lever door hardware.

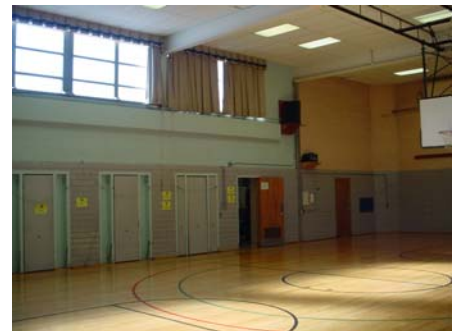
IN-08 Multi-Purpose Room Tables:

Cafeteria tables are built into walls.

Remove built-in cafeteria tables and close in void in wall.
