## **MOUNT PLEASANT MIDDLE SCHOOL**

Livingston School District  
Mount Pleasant Middle School

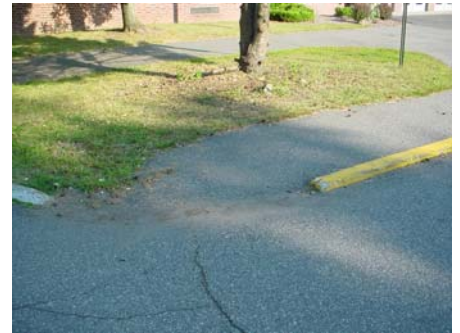
### EX-01 Site:

Concrete walks and platforms are deteriorating and in need of replacement in some locations. Asphalt parking areas, driveways and walks are cracked and broken. Existing striping, directional arrows and fire zone markings are fading and hard to read.

*Cut out and replace cracked, broken and deteriorated sections of concrete walks and platforms. Replace cracked and broken concrete stairs. Provide ADA complying handrails at exterior stairs. Mill and resurface parking areas, driveways and walks, which are cracked and broken. Paint stripe parking bays, directional arrows and fire zone markings. Provide ADA compliant directional signage indicating handicapped accessible routes.*

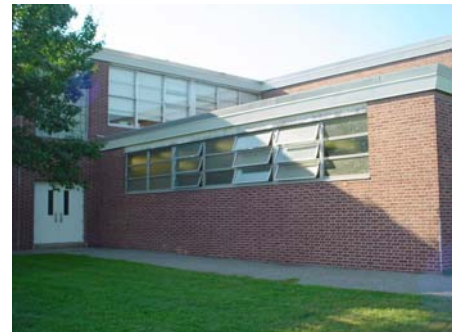
### EX-02 Masonry Walls:

The brick masonry appears in good condition with no major cracking noticed. Caulking at doors, windows, grills and louvers are dried out and cracking. The masonry walls at the 2002 additions are in good condition.

*Even though no water infiltration was observed coming through the masonry walls, any open masonry joints should be cut back and pointed. Re-caulk doors, windows and louvers.*

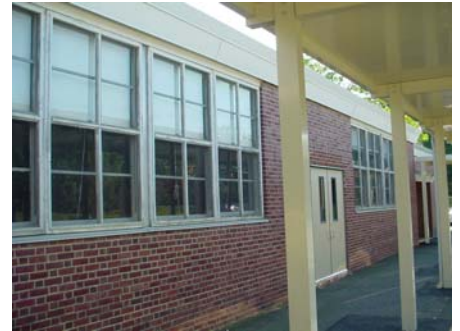
**EX-03 Windows:**

Exterior walls have original aluminum windows, which are single glazed, non-thermal break and energy inefficient. The 2002 additions windows are new, thermal efficient and in good condition.

*Replace the original aluminum windows with new thermal break aluminum windows having 1" thick insulating glass at the Rms. #209 & #210, Shop Tech Rms., Music Rm., and Locker Rm.*

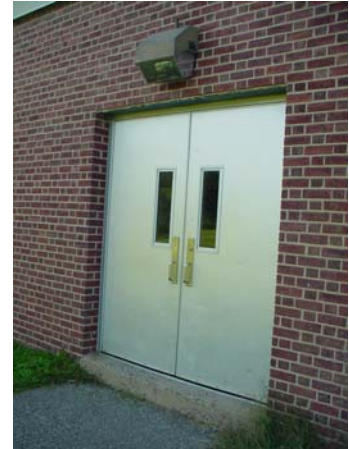
**EX-04 Doors:**

Exterior doors are FRP, without lever handles on the exterior side. Certain doors are 2' - 6" in width, which do not meet the ADA required width. Existing metal frames appear in acceptable condition. The doors, frames and hardware at the 2002 additions are in good condition.

*Replace FRP doors not meeting ADA required width. Replace all hardware on exterior doors with lever handles. Clean existing metal frames and paint same. Replace all caulking at existing frames.*

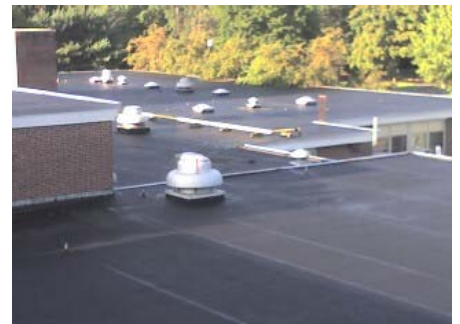
**EX-05 Roofing:**

The built-up roofs at the latest addition are new and in good condition. The EPDM roof above the cafeteria is in poor condition with blistering and field seams failing.

*Replace the EPDM roof that is in disrepair, approximately 6,500 sf. The remaining EPDM roofs should have further investigation through infrared testing to look for signs of wetness and/or dampness.*

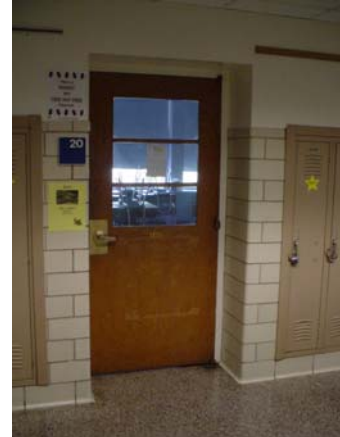
### IN-01 Wood Doors:

Certain corridor doors do not comply with code fire-rating requirements (1/3 hr.). Some corridor door hardware and push/pull hardware do not comply with ADA requirements. Certain doors have louvers in transom panels without fire dampers. Many corridor doors do not meet ADA pull side dimension requirements. The doors at the 2002 additions meet requirements.

*Replace non-complying fire-rated doors with 1/3 hr. rated complying doors and hardware. Replace non-complying door hardware with ADA complying hardware. Replace transom panel louvers with complying fire dampered louvers. Modify masonry opening and provide new doors and frames at non-complying ADA pull side doors.*

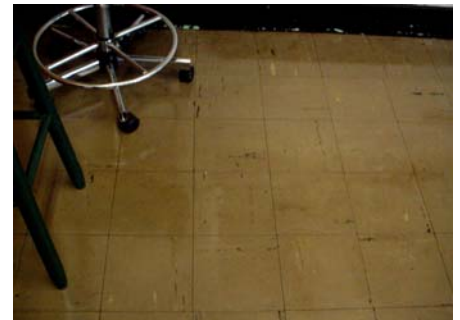
### IN-02 Floor Tiles

Certain rooms have 9" x 9" vinyl tiles in classrooms, which may be indicative of containing asbestos. The floor tiles at the 2002 additions appear to not contain asbestos.

*Even though the tiles are non-friable, it is suggested that the Board have the tiles tested to ascertain if they contain asbestos. The Board may wish to have its abatement consultant prepare a schedule to remove any tile found to contain asbestos. This office will then provide the documents to replace the tile accordingly.*

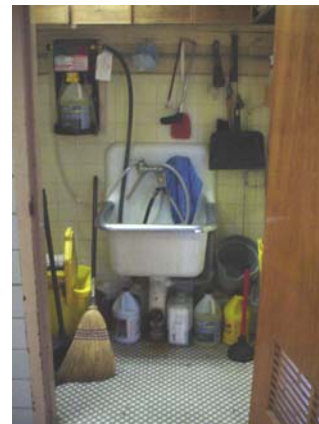
### **IN-03 Janitor Closets:**

Janitor closets were found to be in poor condition due to years of continuous hard use. The closets at the 2002 additions (where provided) appear clean and new.

*Prep and paint all walls, floors and ceilings. Install new slop sinks/mop sinks and stainless steel equipment hanger strips and shelving.*

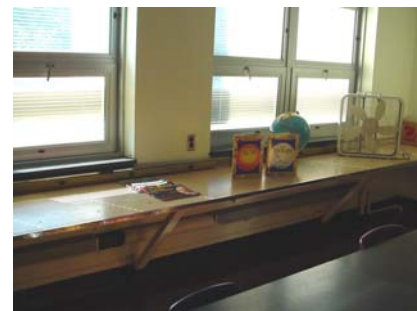
### **IN-04 Second Floor Science Labs:**

The sink, cabinets and counters in the second floor Science Labs are not ADA compliant and out dated.

*Replace the sinks, sink cabinets, and counters to meet ADA, code requirements and latest cabinetry and teaching designs.*

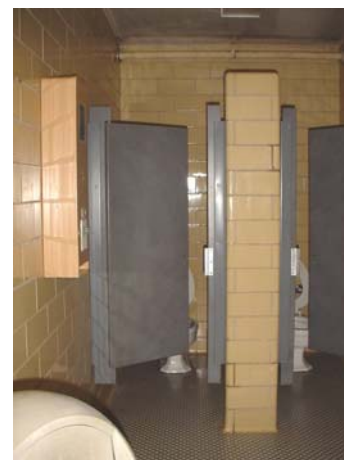
### **IN-05 Toilets:**

A portion of the public toilets have been upgraded to meet ADA requirements. Faculty toilets and locker room toilets do not meet ADA. No insulation on exposed pipes below sinks in some toilets. The 2002 additions' toilets meet all ADA requirements.

*Upgrade required toilet rooms to meet ADA guidelines. Install insulation on exposed piping below sinks.*

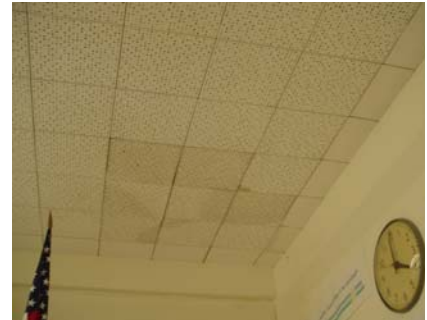
**IN-06 Acoustical Tile Ceiling:**

Most acoustical tile ceiling panels are showing signs of warping due to humidity and discoloring due to age. Some panels are water stained.

*Replace all warped, discolored and stained acoustical tiles ceiling tiles, including lighting.*

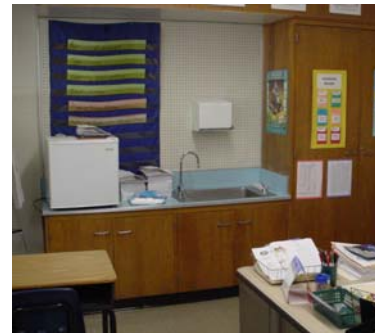
**IN-07 Home Economics Room Gas Range, Sinks and Countertops:**

There is no hood or fire suppression system at the gas ranges. The sinks and countertops are not ADA compliant. Replacement of A.C.T. ceiling is necessary.

*Provide a ventilated hood with fire suppression system over the gas ranges. Provide ADA compliant sinks and countertops. Replace A.C.T. ceiling.*

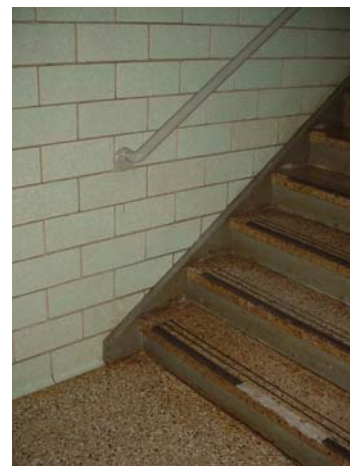
**IN-08 Stair Towers:**

Handrails do not have ADA compliant extensions. Doors do not have latchable lever handrails. Stair treads are terrazzo with some having broken and missing nosings. Non-structural cracks in terrazzo flooring.

*Install new ADA compliant handrails with extensions. Install new fire-rated doors, transoms, frames and code-complying hardware. Replace broken and damaged terrazzo treads with new terrazzo treads having non-slip nosings.*

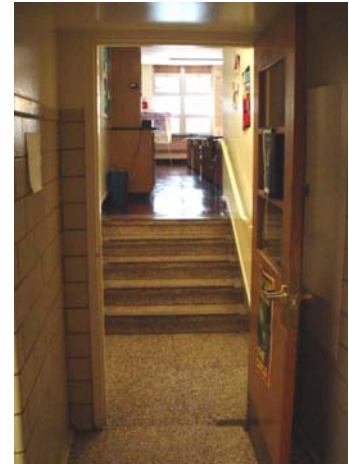
**IN-9 Science Classroom:**

Science Lab #219 on the second floor can only be accessed by stairs.

*Provide handicap access stair lift.*

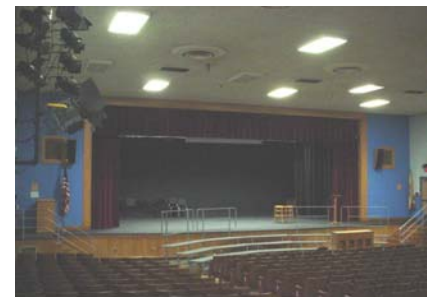
**IN-10 Auditorium:**

The auditorium does not have provisions for handicap seating in accordance with ADA requirements. There is no handicap lift access to the stage. The flooring is non-acoustical vinyl tile. The seats are the original wood chairs. The auditorium appears to be lacking modern acoustical sound treatments.

*Renovate and upgrade entire Auditorium. Provide handicap seating and hearing devices conforming to ADA requirements. Provide a handicap lift for access to the stage. Replace the vinyl flooring tiles with carpeting. Replace the original wood chair seating with modern upholstered seating. Provide acoustical sound treatments to the auditorium wall surfaces. Provide new sound system and lighting. Provide new stage lighting. Provide new acoustical ceiling. Provide air conditioning. Provide new stage curtains.*

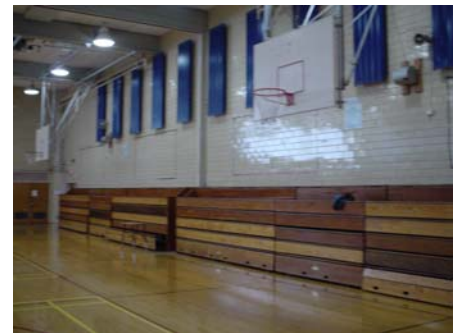
### **IN-12 Gym Bleachers:**

Bleachers need replacement.

*Replace with new bleachers complying with ADA.*
