**MOUNT PLEASANT ELEMENTARY SCHOOL**

Livingston School District  
Mount Pleasant Elementary School

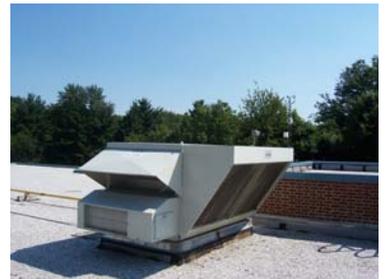
Office Areas – The elementary school admin area utilizes window air conditioners.

Media Center – The media center utilizes a newer gas-fired, heating/cooling rooftop unit.

*Though no immediate upgrades are required, consideration should be given to provide cooling to the classrooms, auditorium, cafeteria and gymnasium. Vertical, self-contained heating/cooling units are recommended for the classrooms, while multiple rooftop units with heating/cooling are recommended for the larger spaces (i.e. activity room & gym/cafeteria).*

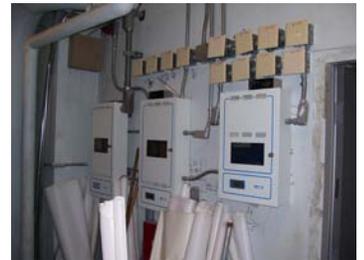
The fire alarm system is an Edwards Systems Technology IRC-3 addressable fire alarm system which is a mix of newer addressable and older non addressable equipment.

This fire alarm system serves both the middle school and elementary school. Existing system does not meet current requirements. There are missing several strobes and pull stations.

We could not visibly see the hood Ansul system connection to the fire alarm system.

*Proceed with the board of education's plans to replace the fire alarm system in December of 2007.*
