ADMINISTRATION BUILDING

Livingston School District
Administration Building

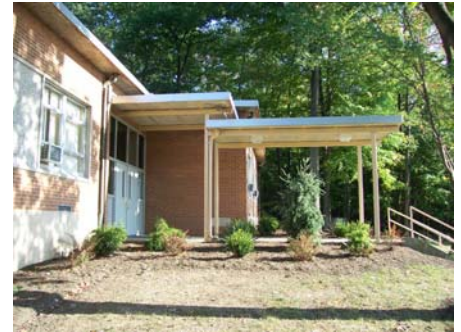
The Livingston Board of Education Administration Building is located at 11 Foxcroft Drive and consists of a two-story building with garage space occupying the partial lower level. One small Addition was added at a later date to accommodate additional offices and computer spaces.

In general, the site elements are in fair condition with some paving repair needed at parking areas and driveways, with new striping, directional arrows and fire zone markings.

The exterior brickwork is in good condition and there were no signs of water infiltration through the exterior walls. The windows are aluminum, single glazed, original and in fair condition. There is a separate roof condition analysis for this building elsewhere in the report. There was no sign of water infiltration through the roofs. The exterior doors are mostly FRP doors in hollow metal frames.

The interior of the building consists of masonry walls, carpet and 9" x 9" asphaltic floor tiles, (which may be indicative of containing asbestos in a number of rooms) and wood doors. There are many handicapped measures not complied with, i.e., door hardware, entrance door widths and toilets.
