COLLINS ELEMENTARY SCHOOL

Livingston School District
Collins Elementary School

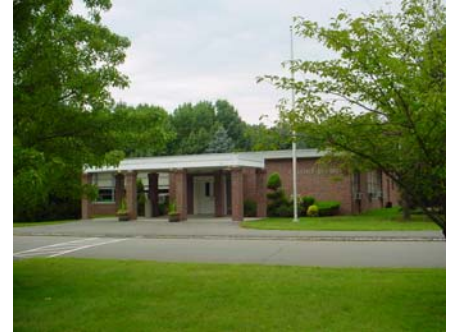
Collins Elementary School is located at 67 Martin Road and consists of a one-story building, which has had a number of additions added to it over the years, the latest of which was a one-story Multi-Purpose Room and Classroom Addition completed in 2002. The existing building has masonry walls, tectum roof decks and concrete slab on grade. The new additions (2002) have masonry walls, metal deck at the roofs and concrete slabs on grade. The 2002 additions appear to meet all code requirements.
