HARRISON ELEMENTARY SCHOOL

Livingston School District
Harrison Elementary School

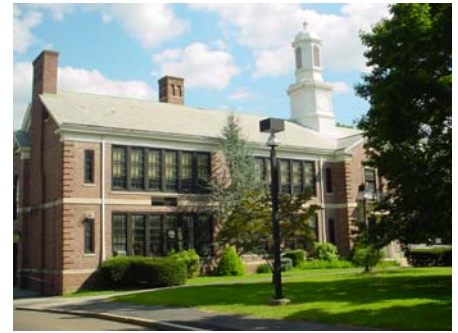
In general, the site elements are in fair condition. Concrete sidewalks, curbs, concrete stairs and ramps are in need of repair. The masonry walls at the exterior concrete ramp outside of the 1929 building east stair is crumbling. Asphalt milling and paving is needed at driveways, parking and play areas, along with new striping, directional arrows and fire zone markings. ADA directional signage needs to be provided and the handicapped accessible access routes clearly marked with ADA compliant signage. The original two-story building does not have an elevator for HC access to all building levels. The main entrance has an ADA complying entrance ramp to the first floor.

Install ADA complying depressed curb drops. Cut out broken, sunken and deteriorated sections of concrete walkways and concrete curbing. Replace the wall at the exterior concrete ramp adjacent to the east stair tower. Mill and resurface the drives, parking and play areas. Paint stripe parking bays, directional arrows and fire zone markings. Provide ADA directional signage for the ADA accessible access routes from the H.C. drop-off and parking stalls to the accessible building entrances. Reconstruct deteriorated concrete and masonry stairs.

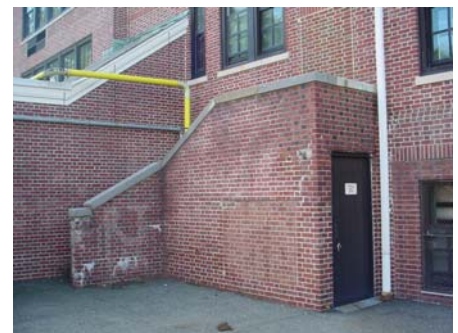
The exterior brickwork is in fair condition and needs cleaning and repointing at the 1929 building. The masonry stairs at the 1929 building are cracked, broken and in disrepair. Doors and window lintels are rusting and peeling paint. The main front entrance to the building has limestone, which is stained and missing mortar joints. The wrought iron railing balustrade above the front entrance is rusting and peeling paint. The wood fascias, soffit and trim are peeling paint. The aluminum leaders are without leader heads. Windows and doors have dried, loose and missing caulking. Control joints are missing caulking.

Replace broken and cracked brick. Cut out and repoint brick joints where loose, deteriorating and missing. Replace broken limestone. Cut out and repoint limestone joints. Clean all brick and limestone. Scrape and paint steel lintels at windows and doors. Scrape and paint the wrought iron balustrade above the main entrance. Scrape and paint wood fascias and trim. Replace aluminum leaders, providing leader heads and necessary base clean outs. Re-caulk perimeter of all grills, louvers, windows and doors. Install caulking at control joints, which is missing, and remove mortar splashings from the face brick on the entire east wall of the 2002 Gymnasium Addition. Remove the rotting wood stair at the rear of the 1929 building and replace with a new concrete stair. Replace non-ADA compliant handrails and provide new handrails at locations requiring same. Replace the cracking and deteriorating brick stairs with new concrete stairs at the rear of the 1929 building.

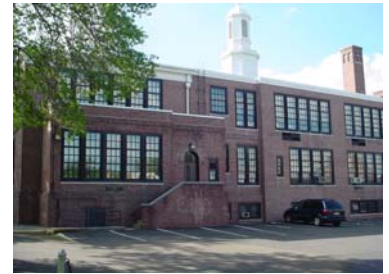
Despite the aforementioned, no signs of severe water infiltration through the exterior walls were observed. The wood stair at the rear of the 1929 building is rotting. Exterior stair railings are either missing or not ADA complaint. The windows at the 1929 original building have been replaced with double hung aluminum windows having insulating glazings. Many of the double hung sash are in need of new balances. All other windows, except at the 2002 Addition, are aluminum, non-insulating, single glazed in need of replacement. The doors, frame and transom at the front entrance are in need of replacement. All exterior doors, except at 2002 Addition, do not have ADA compliant level handles. Exterior miscellaneous louvers and grills are dented and damaged.

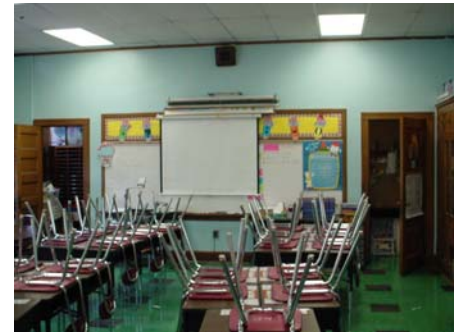
The interior of the building consists of masonry walls, some having glazed masonry facings, some with painted plaster finish and plain concrete block painted. Scattered throughout the building are sheetrock walls. There are terrazzo floors, 12" x 12" vinyl floor tiles, carpet, ceramic tile and 9" x 9" asphaltic floor tiles (which may be indicative of containing asbestos in a number of rooms). Toilets, doors, stairways, sinks, counters, ramps and handrails were found in non-compliance with construction code and ADA requirements. Chalkboards, tackboards, floor and wall finishes, acoustical panel ceiling tiles, janitor closets, etc., were found to be in need of refurbishing and replacement due to many years of continuous hard use. Room signage was either missing, non-informative as to correct room use and non-ADA compliant. There is no lift up to stage floor for HC access. The Guidance Area is in the old locker room area.
