HERITAGE MIDDLE SCHOOL

Livingston School District
Heritage Middle School

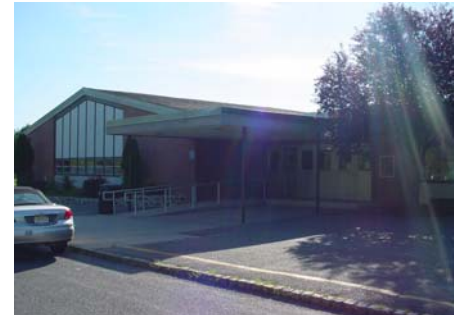
In general, the site elements are in good condition with some Belgian block curbing in need of repair and cracked concrete walks and concrete steps in need of replacement. Asphalt milling and paving is needed at cracking and broken parking, driveway and walk areas. ADA directional signage needs to be provided and the handicapped accessible access routes clearly marked with ADA compliant signage. New striping, directional arrows and fire zone markings are needed.

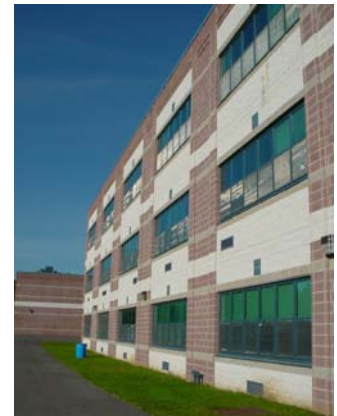
The exterior brickwork is in good condition. The brickwork at the bottom of the window walls is stained and streaked. The windows are in original aluminum curtain walls, single glazed and in poor condition. Many of the window sashes do not operate correctly and are drafty due to their construction and age. Perimeter caulking of windows and doors is dried and cracking. There is a separate roof condition analysis for this building elsewhere in the report. The exterior doors are mostly FRP doors in hollow metal frames. Most exterior doors do not have ADA compliant lever handles. Some doors have security coded entrance locks.
