MOUNT PLEASANT ELEMENTARY SCHOOL

Livingston School District
Mount Pleasant Elementary School

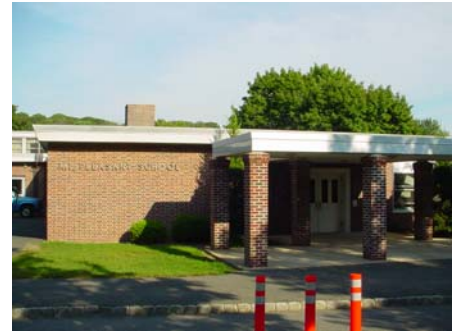
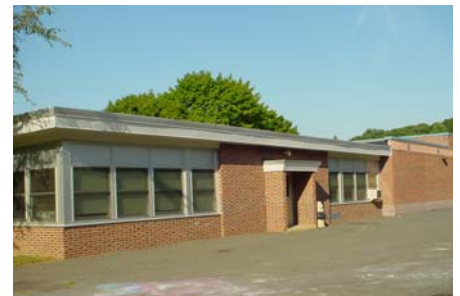
The Mount Pleasant Elementary School is located at 11 Broad Lawn Drive and consists of a one-story building with one-story additions completed in 2002. The building has masonry walls, concrete floor slabs and metal roof decks. The 2002 additions appear to meet all code requirements.

In general, the site elements are in good condition with some concrete walk and concrete platform areas in need of replacement. Asphalt milling and paving is needed at cracking and broken parking, driveway and walk areas. ADA directional signage needs to be provided and handicapped accessible access routes clearly marked with ADA compliant signage. New striping, directional arrows and fire zone markings are needed.

The exterior brickwork is in good condition. The windows are original, aluminum with single glazed sash and in poor condition. Many of the sashes do not operate correctly and are drafty due to their construction and age. Perimeter caulking of windows, doors, louvers and grills is dried and cracking. There is a separate roof condition analysis for this building elsewhere in the report. The exterior doors are mostly FRP doors within hollow metal frames. Most exterior doors do not have ADA compliant lever handles.

The interior of the building consists of glazed masonry units and painted concrete masonry unit walls, 12" x 12" vinyl floor tiles, terrazzo flooring and 9" x 9" asphalt floor tiles (which may be indicative of containing asbestos in a number of rooms). There are many handicapped measures not complied with, i.e., door hardware, door widths, toilets, handrails, fire-rated corridor doors, stairways, cabinets and counters.
