## **MOUNT PLEASANT MIDDLE SCHOOL**

Livingston School District  
Mount Pleasant Middle School

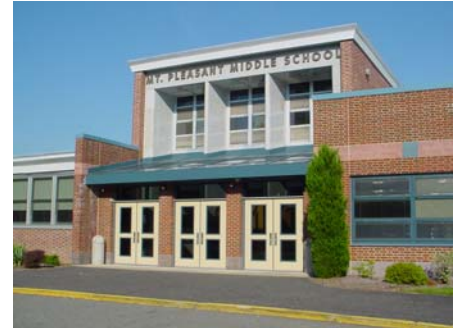
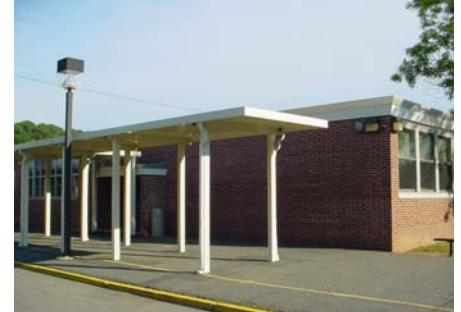
The Mount Pleasant Middle School is located at 11 Board Lawn Drive and consists of a two-story building with one-story additions completed in 2002. The building has masonry walls, concrete floor slabs and metal roof decks. The 2002 additions appear to meet all code requirements.

In general, the site elements are in good condition with some concrete walk and concrete platform areas in need of replacement. Asphalt milling and paving is needed at cracking and broken parking, driveway and walk areas. ADA directional signage needs to be provided and handicapped accessible access routes clearly marked with ADA compliant signage. New striping, directional arrows and fire zone markings are needed.

The exterior brickwork is in good condition. The windows are original, aluminum with single glazed sash, and in poor condition. Many of the sashes do not operate correctly and are drafty due to their construction and age. Perimeter caulking of windows, doors, louvers and grills are dried and cracking. There is a separate roof condition analysis for this building elsewhere in the report. The exterior doors are mostly FRP doors within hollow metal frames. Most exterior doors do not have ADA compliant lever handles.

The interior of the building consists of glazed masonry units and painted concrete masonry unit walls, 12" x 12" vinyl floor tiles, terrazzo flooring and 9" x 9" asphalt floor tiles (which may be indicative of containing asbestos in a number of rooms). There are many handicapped measures not complied with, i.e., door hardware, door widths, toilets, handrails, fire-rated corridor doors, stairways, cabinets and counters.
