**MOUNT PLEASANT ELEMENTARY SCHOOL**

Livingston School District  
Mount Pleasant Elementary School

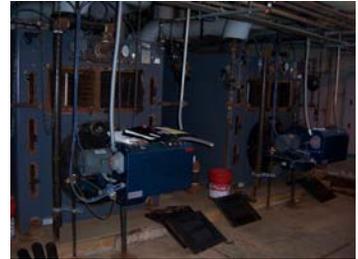
**M-01 Heating Plant:**

See middle school report.

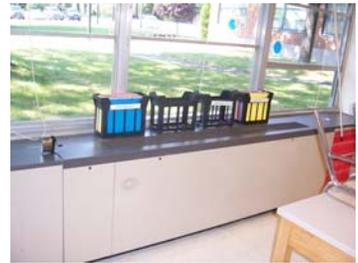
**M-02 Heating & Ventilating Systems:**

Classrooms – Almost all older classrooms are served by steam unit ventilators with supplemental fin-tube radiation. The units are original to the building and appear to be in fair to poor condition and have well exceeded their expected operating life. Some older classrooms have been upgraded with new hot water unit ventilators with supplemental fin-tube radiation. Newer (renovated areas) are served by new RTU's. A few window air conditioners are present to provide cooling to select rooms. Operating along with the unit ventilators, are exhaust fans, which assist in maintaining building pressure. Some fans were not energized and some appeared in need of repair.

Gym/Cafeteria - The room is served by steam heating & ventilating (H&V) units. The units are original to the building and appear to be in fair condition, though they have exceeded their expected operating lives.

Activity Room – The room utilizes steam unit ventilators to provide space heating and ventilation.

Media Center - The media center utilizes a newer gas-fired, heating/cooling rooftop unit.

Miscellaneous Areas – The main circulation corridors utilize hot water cabinet unit heaters, but currently receive no ventilation to the space.

*Spaces such as the classrooms, gym/cafeteria and activity room should have the HVAC equipment replaced since it has been in service long after its expected operating life. The new equipment will replace the existing equipment in-kind, except that additional outdoor ventilation air will be introduced per today's codes and the new equipment will be fitted with microprocessor controllers to integrate with a building control system. Areas that receive little or no ventilation must be upgraded as required. Conversion of the steam system to a hot water system is desirable for better controllability. Exhaust fan maintenance should be addressed by repairing units where possible and replacing those in bad repair. In addition, boilers should be retrofitted to operate as hot water (instead of steam). New piping, pumps and controls are required. Previously installed heater exchangers can be removed.*

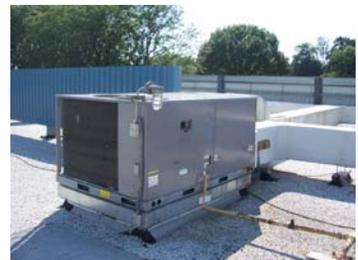
**M-03 Cooling Systems:**

Office Areas – The elementary school admin area utilizes window air conditioners.

Media Center – The media center utilizes a newer gas-fired, heating/cooling rooftop unit.

*Though no immediate upgrades are required, consideration should be given to provide cooling to the classrooms, auditorium, cafeteria and gymnasium. Vertical, self-contained heating/cooling units are recommended for the classrooms, while multiple rooftop units with heating/cooling are recommended for the larger spaces (i.e. activity room & gym/cafeteria).*
